Exhibit 2
City Owned Facilities Summary

CITY OWNED FACILITIES SUMMARY

Date: July 2009

**CITY OF SULTAN
Facility Assessment Study
July 24, 2009**

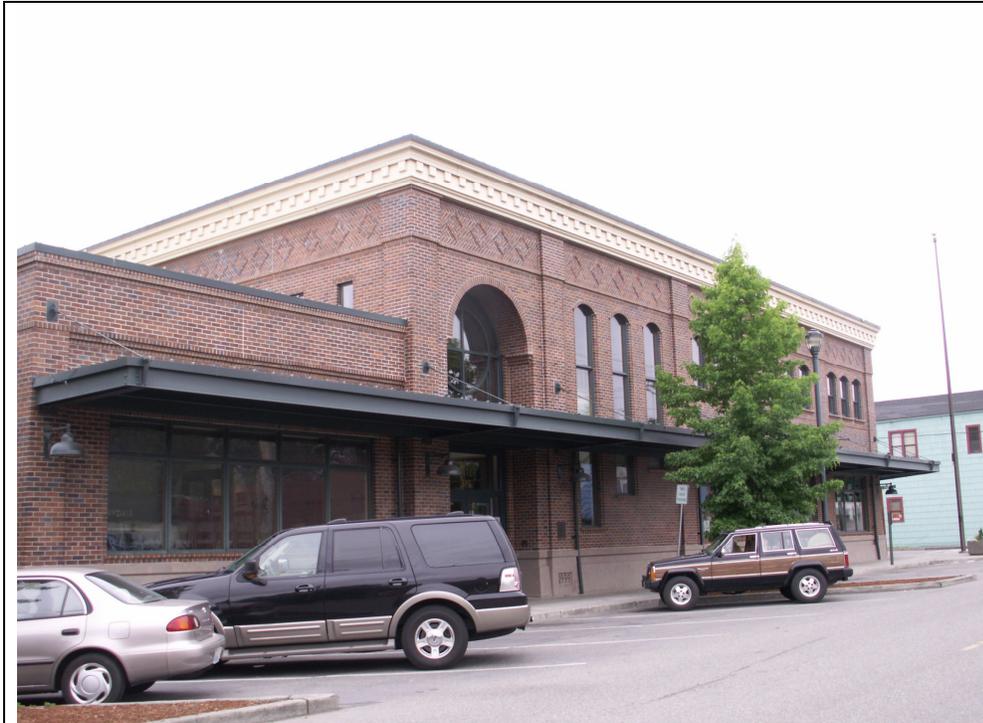
Exterior of City Hall – Lower 3’ of wall, concrete needs cleaning and repainting.

7. Exterior Walls: Most of the exterior walls are face brick that is in good condition. The base of the wall up about 3 feet is of stained or integral color concrete. This concrete surface is dirty and needs cleaning and repainting.

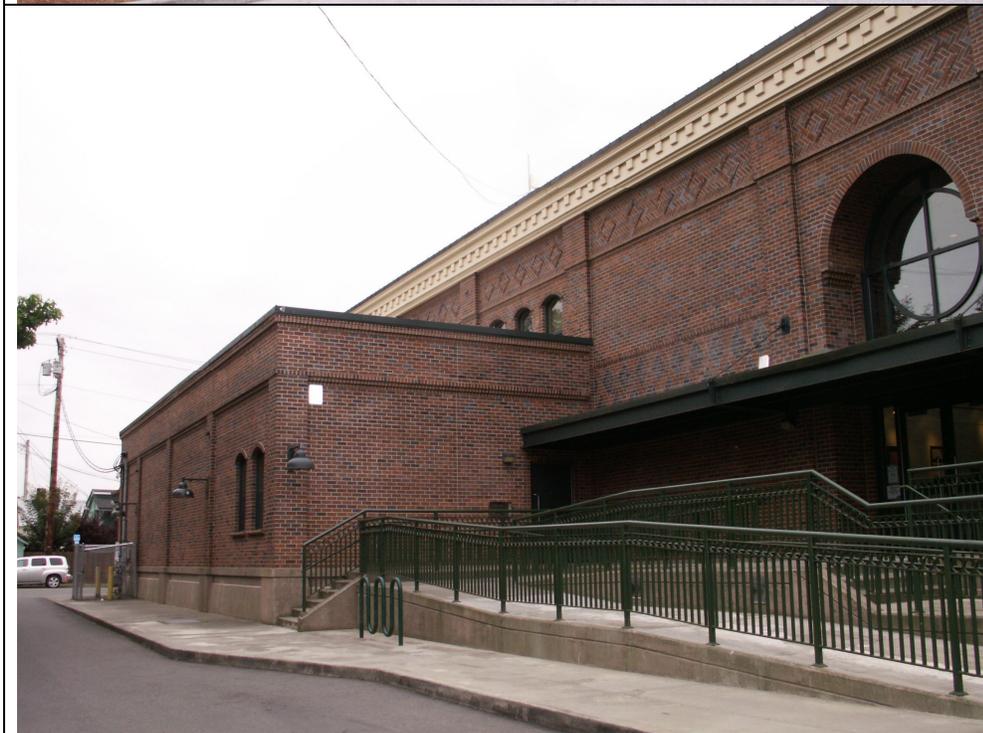
Exterior of City Hall – all exterior steel needs repainting and in some places primer is needed on rust spots.

3. Site Steel Railing and Painting: The exterior steel railings are in need of repainting with touch-up primer on the rust spots. This includes the structural steel elements on the canopy. The fascia metal and cap metal needs cleaning.

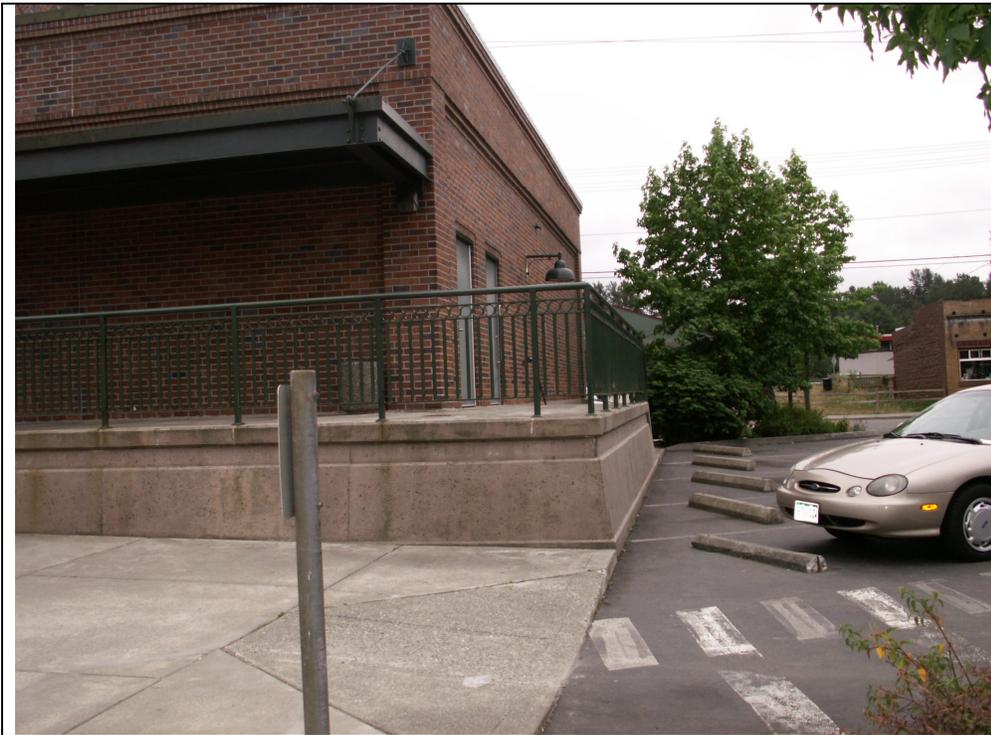
Parking Lot –
location of
handicap parking
not convenient,
re-striping needs
to occur.

4. Parking Lots: The parking lot is in pretty good condition. The striping needs to be repainted. There are trash bins in the handicapped parking stall. The handicapped parking stall is across the parking lot from the building entrance ramp. I do not understand why the stall on the building side of the parking lot is not the barrier-free stall.

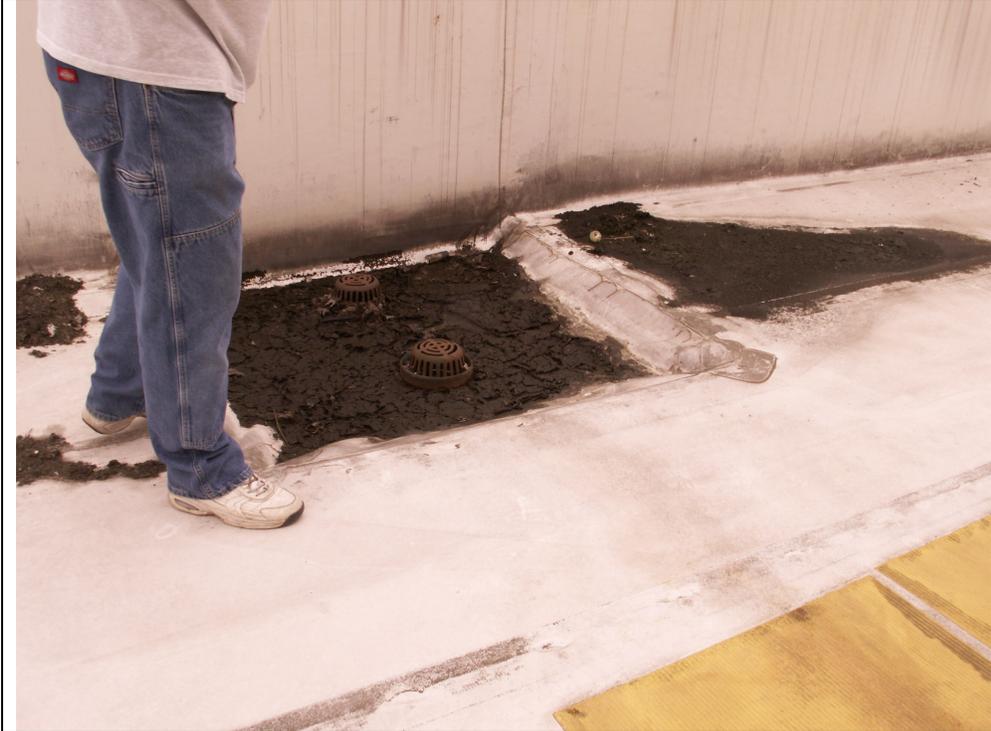
Roof Drains
clogged, need to
be swept and
cleaned regularly.

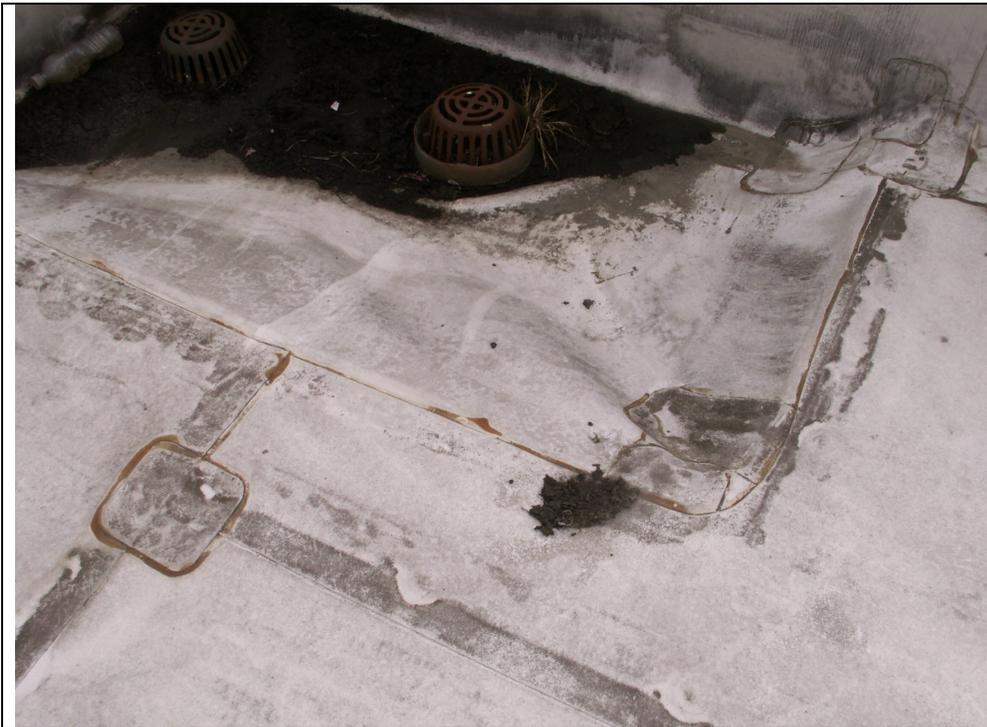
Roof Drains and bubbling of roof membrane

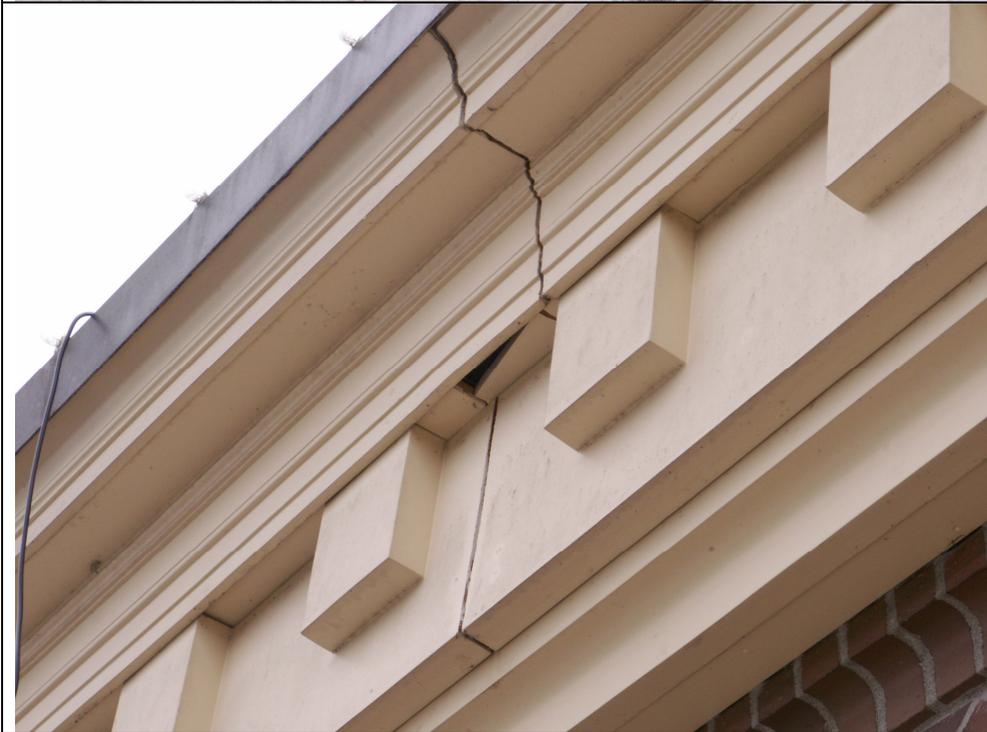
Cornice Work needs repair. Sealant and backer rod installed around entire building recommended.

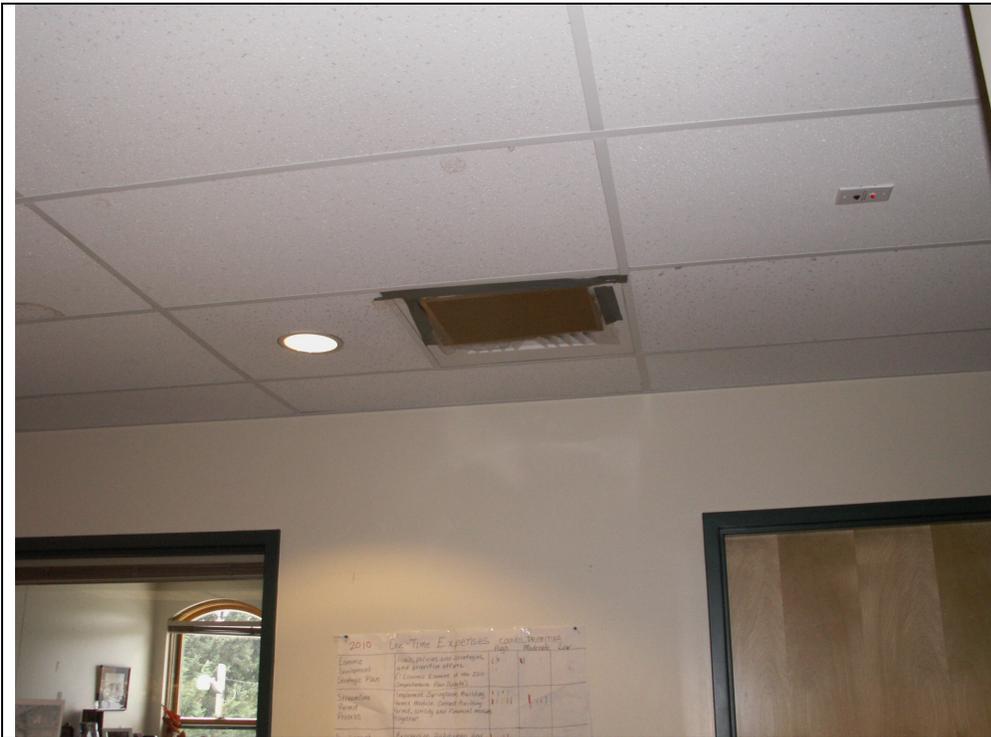
Ceiling water stains and dripping. Walls all need to be repainted soon.

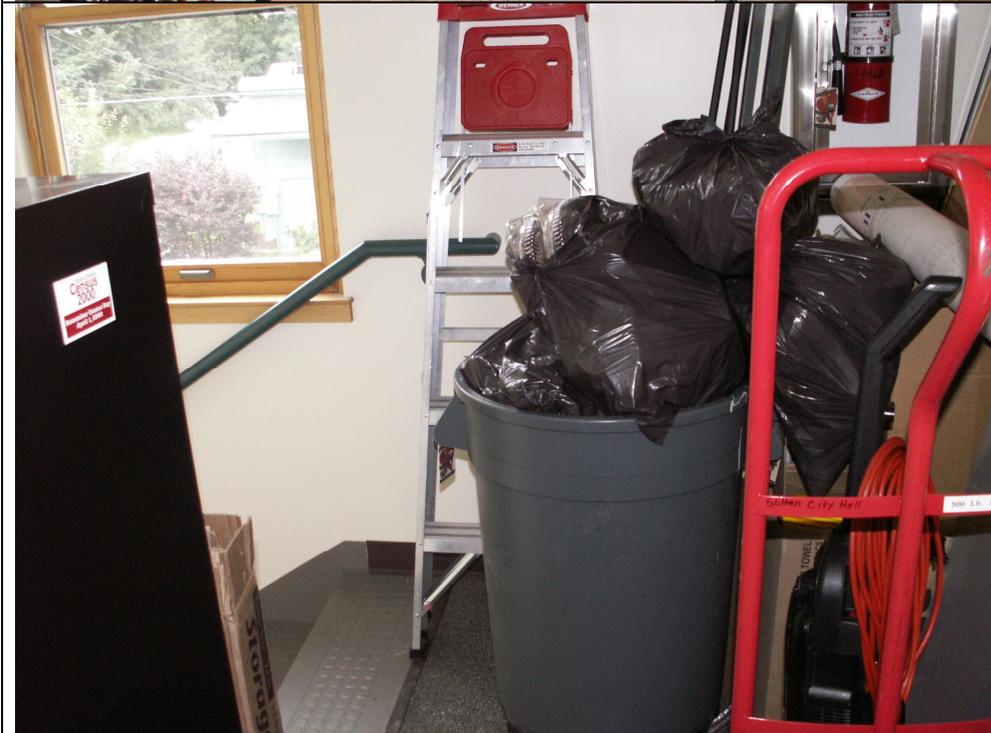
Emergency Exit Stairs – currently being used as storage and is dangerous in case of emergency. Also, no emergency pathway lighting.

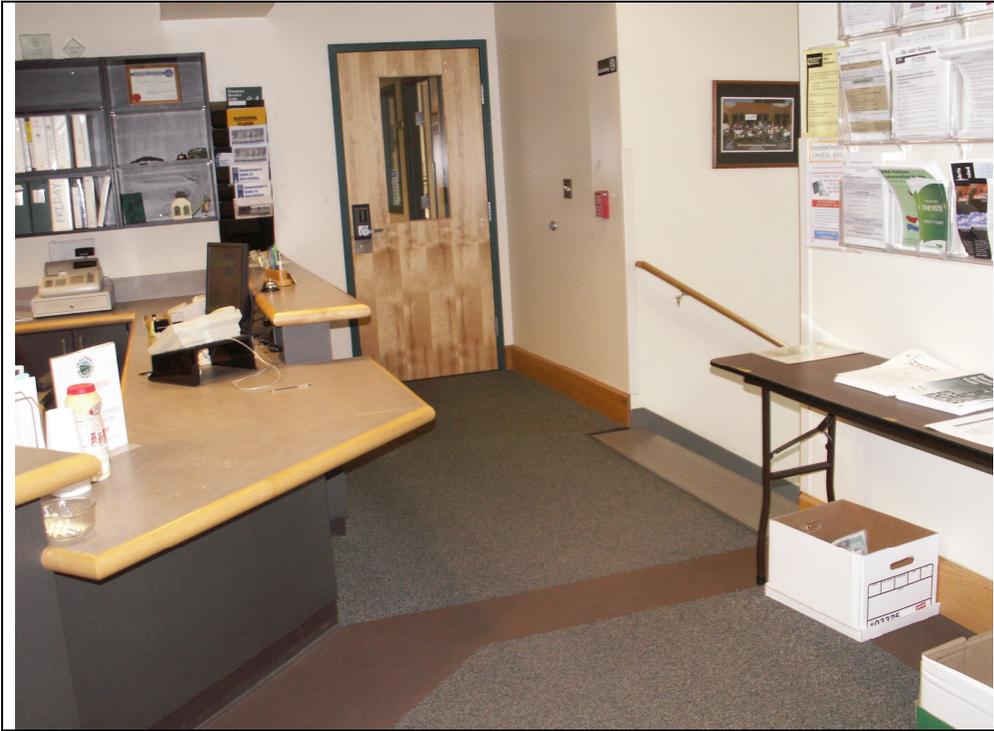
Interior Stairs – rubber treads appear to be code compliant, but railing is not. It has residential brackets and is missing the extensions on the top. Landing at top of stairs is small and not adequate.

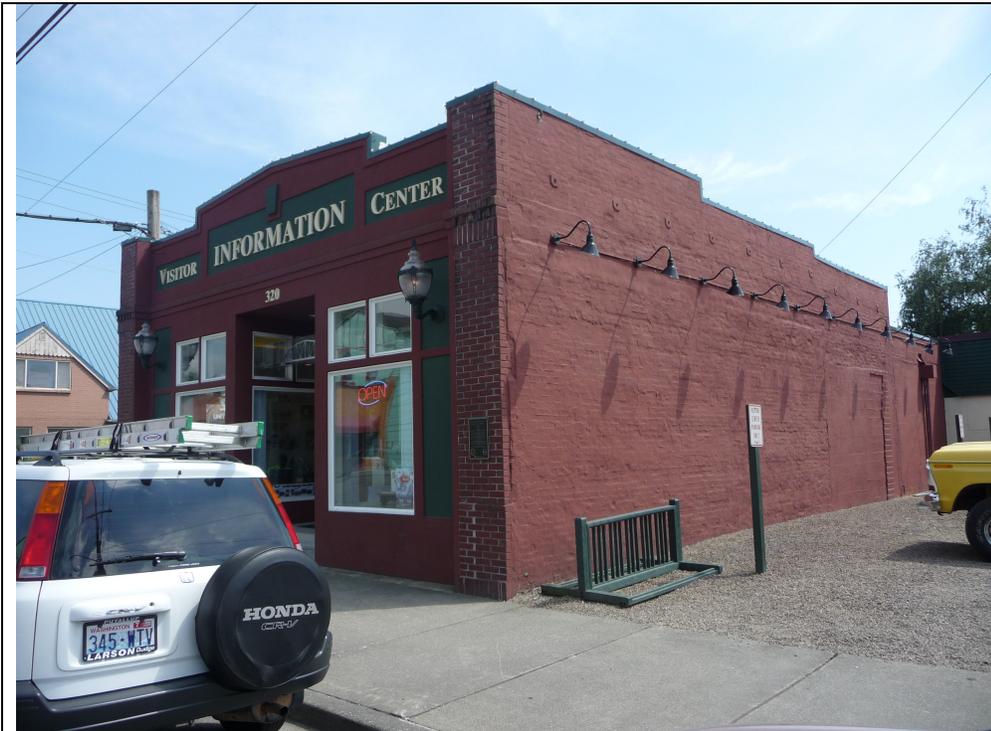
Exterior of Visitor Information Center – Lights are pulling away from wall and need to be repaired soon.

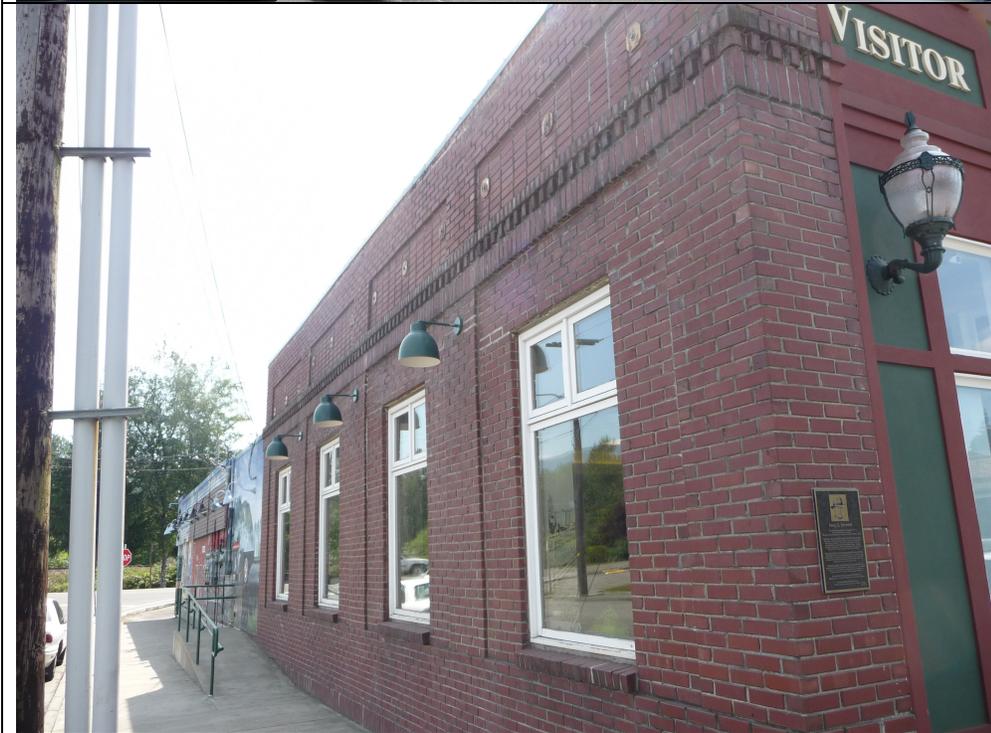
Exterior of wood windows show surprising rapid deterioration. Sash needs to be recaulked and there is rot in the sill sash on 3 of the 4 windows.

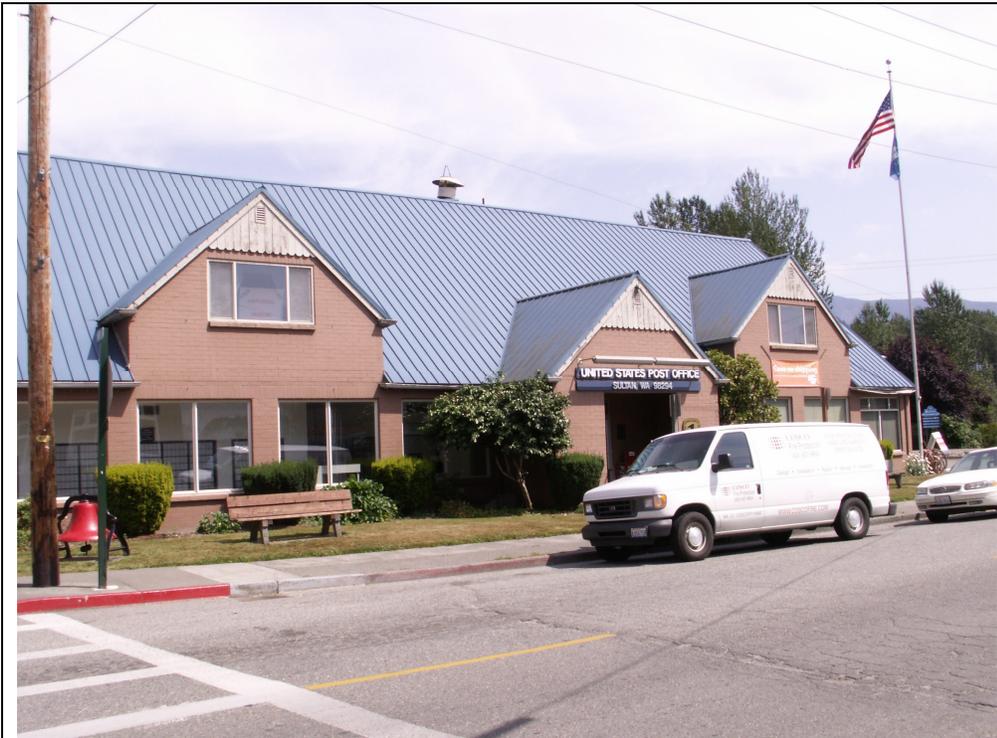
Exterior of Post Office –
Repainting of brick on a regular schedule is recommended.

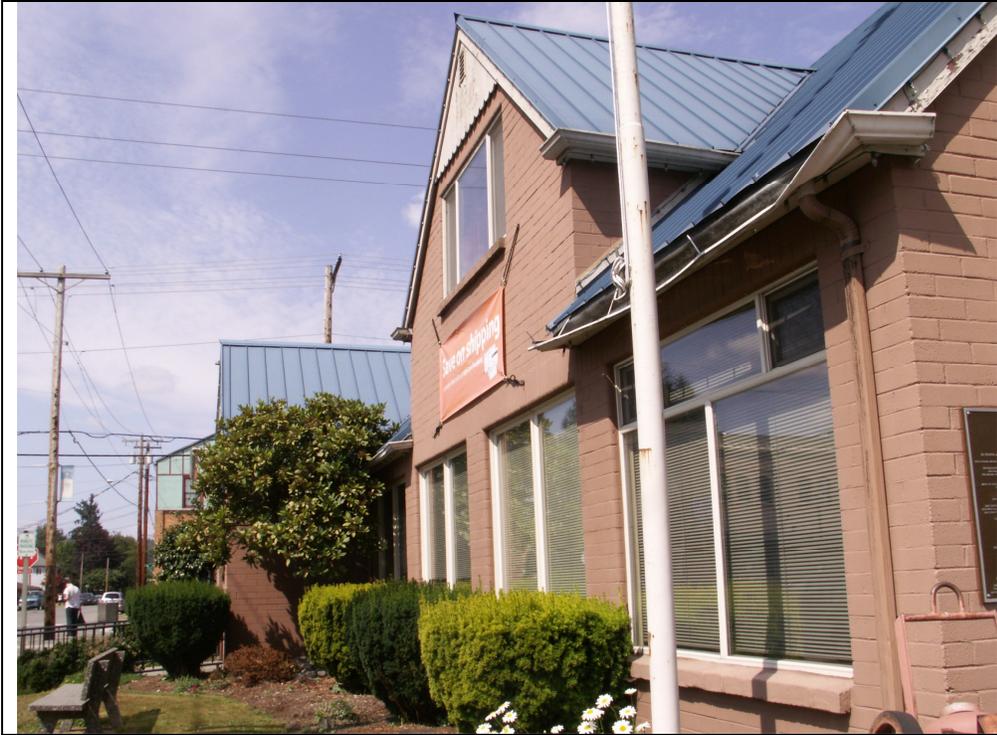
Fascia board has some rot, wood siding is peeling and needs repainting, gutters are in bad condition and need replacing. Multiple locations of bad roof joints – could cause water intrusion.

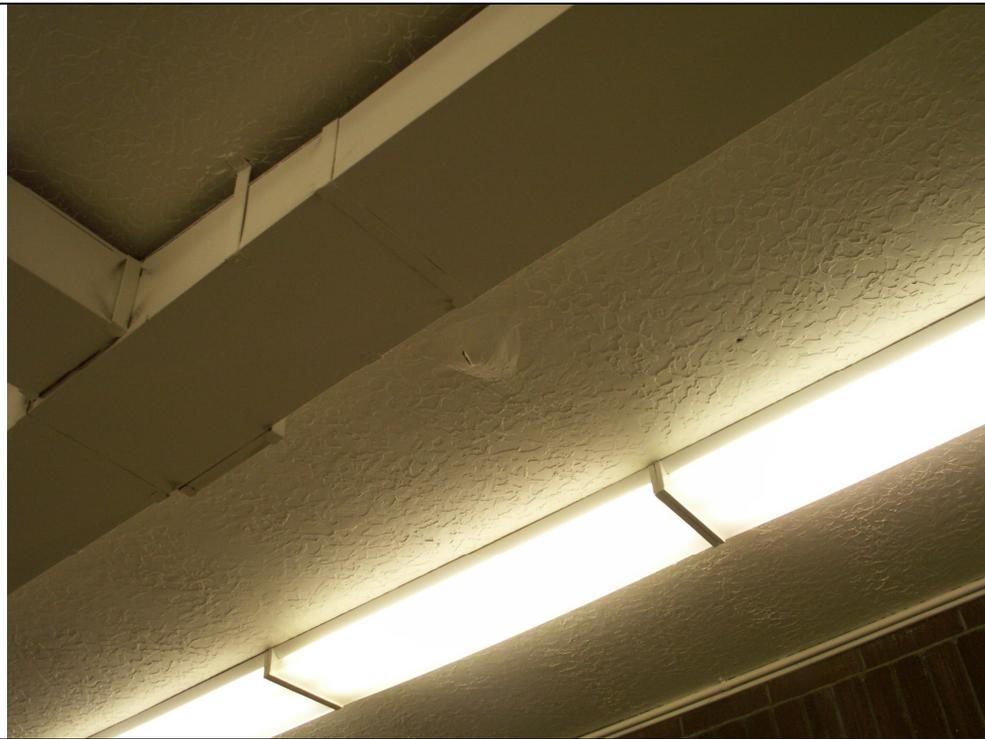
Multiple places in the ceiling like this, showing water damage.

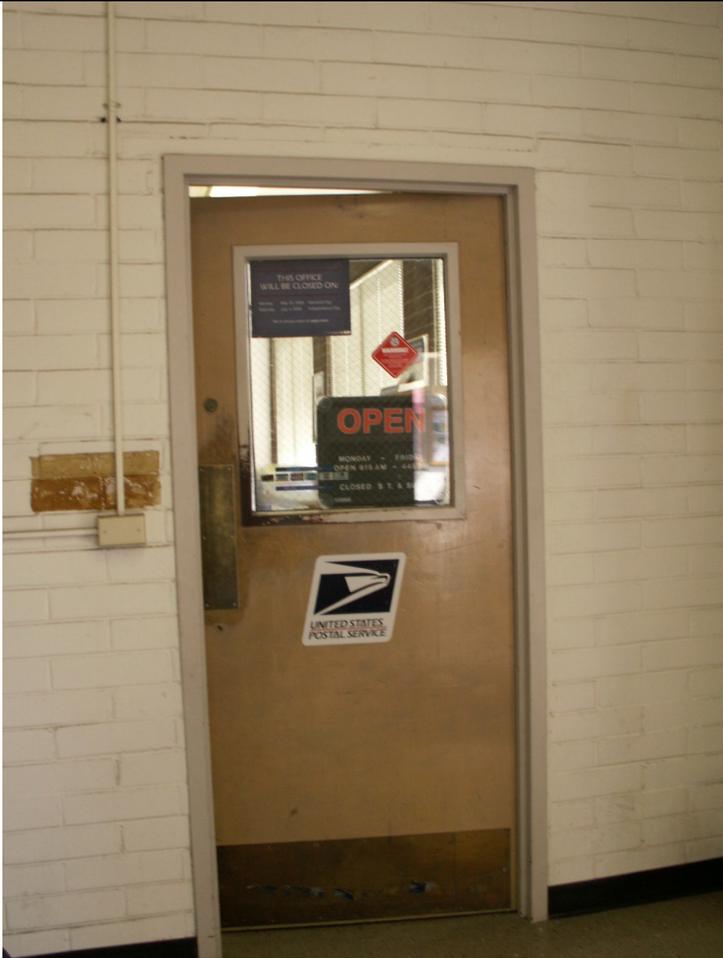
Interior walls need repainting. Interior doors are in bad shape and inappropriate for their location. Exterior door replacement recommended.

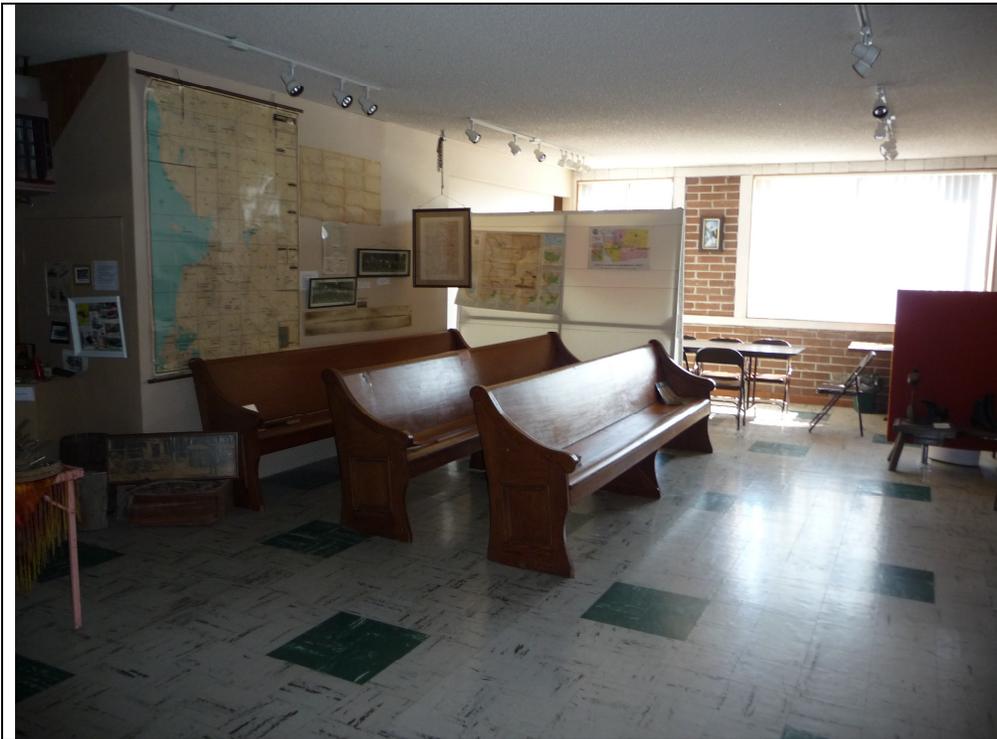
Museum floors appear to be 9x9 vinyl tiles.

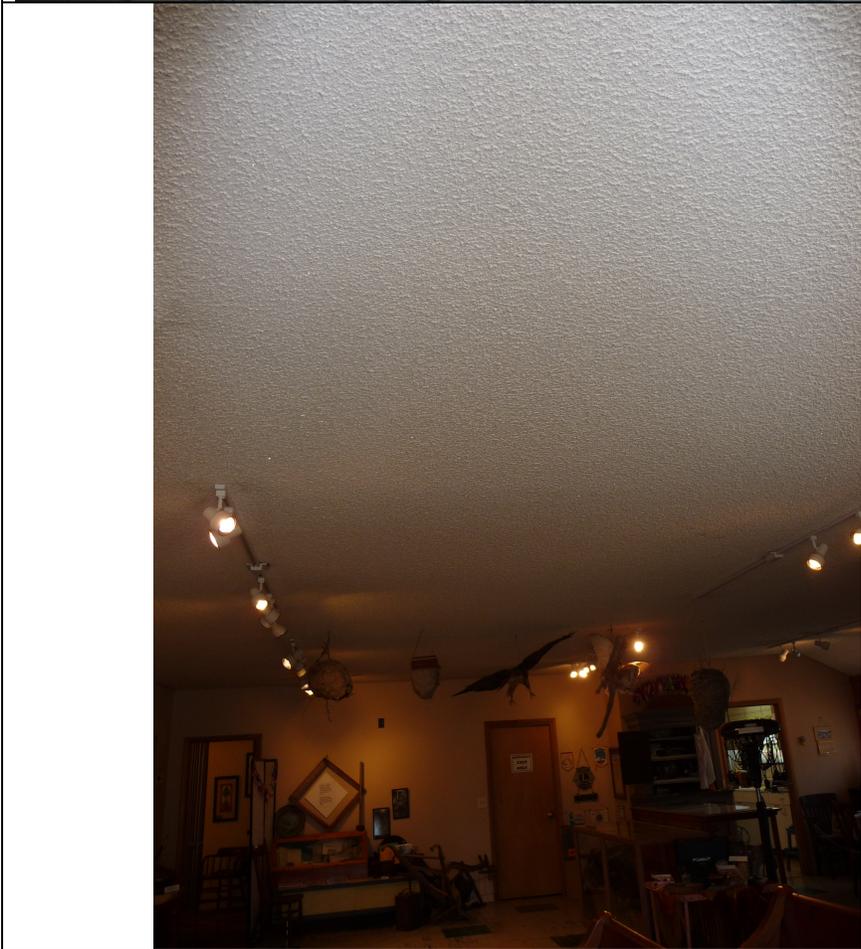
Main ceiling texture needs to be checked.

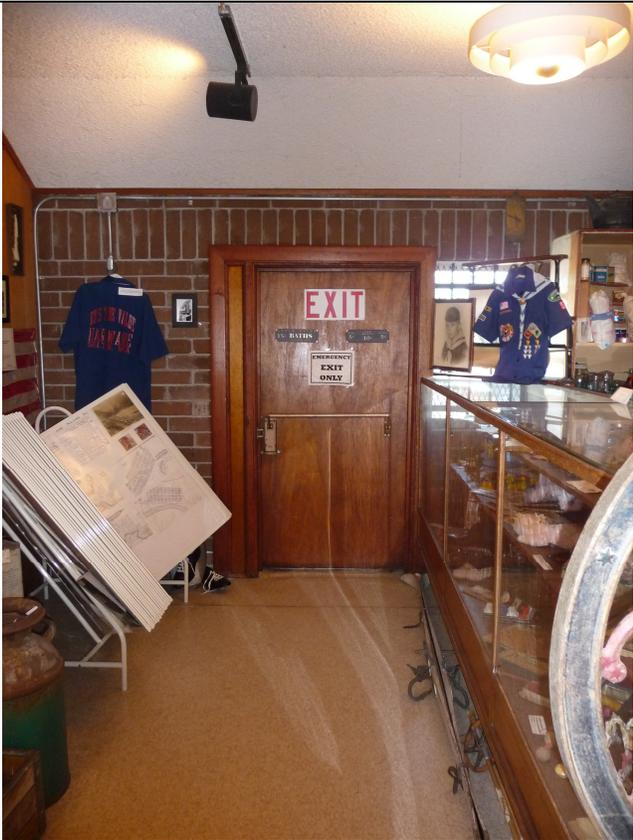
Emergency exit doors. There are two exit doors, both which are about 6’-6” tall. Neither door has appropriate panic hardware (the door pictured had hardware that is mounted upside down). Both exits’ stairways are unsafe and one ends in a planter bed. This space does not have sufficient emergency egress and needs to be updated.

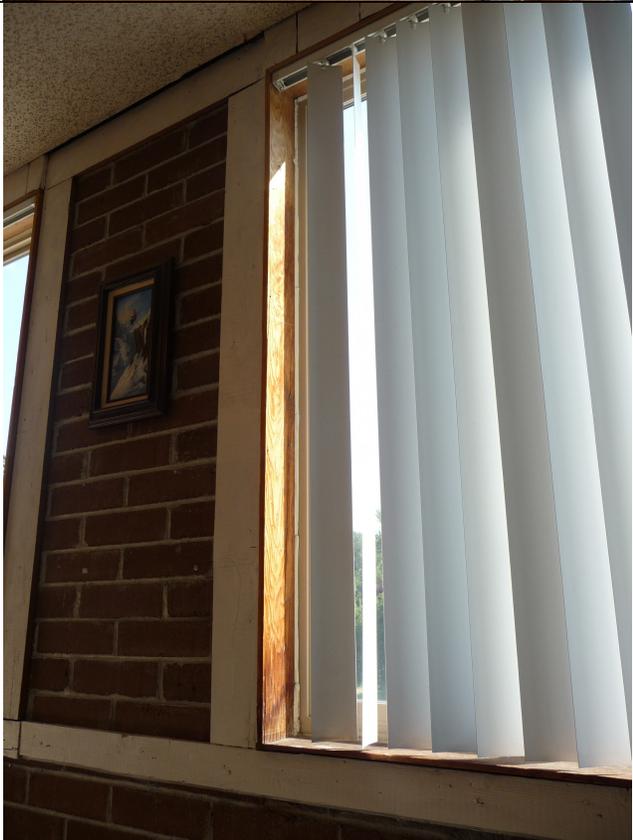
Exterior windows. South side of building is missing screens. Interior wood frames are splitting and cracking – could be due to moisture. Need to be fixed or replaced.

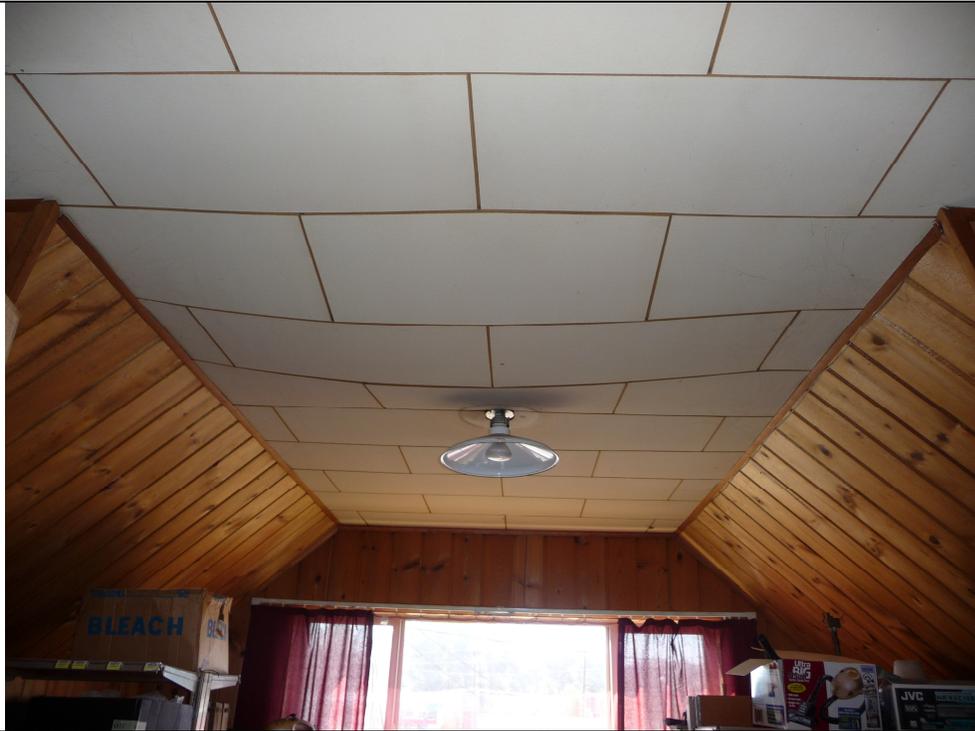
Ceiling in storage room is bowing. Could be water damage from the roof leaking.

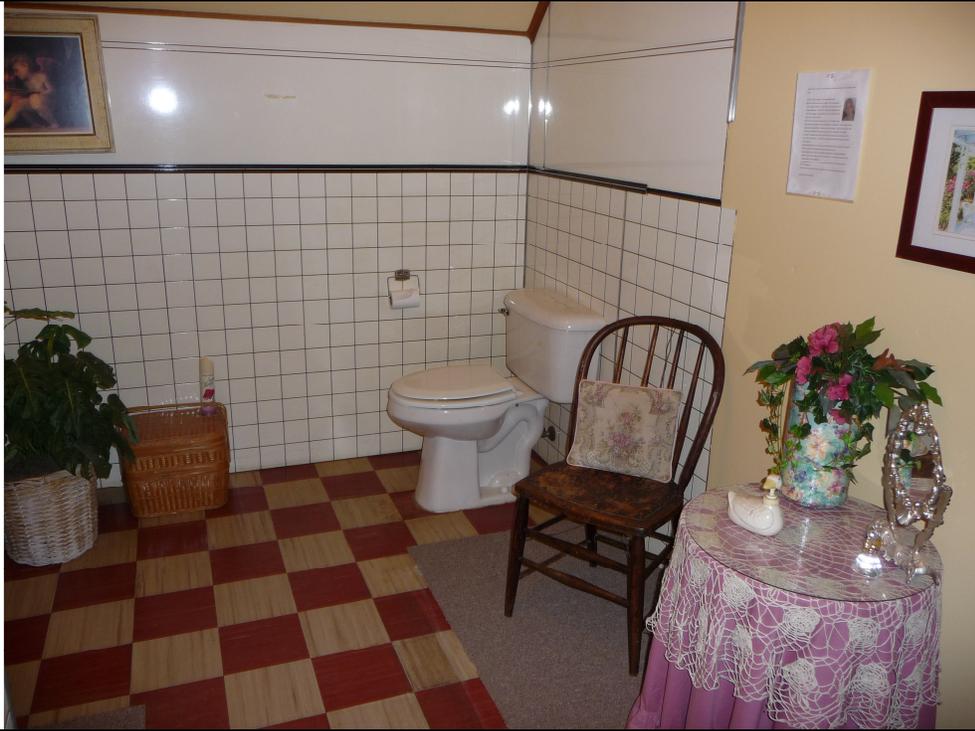
Restroom is large enough to be ADA but is not. Missing grab bars, carpet causes an unsmooth surface, sink is not accessible. Wall finish needs to be updated and completed – multiple areas missing wall finish.

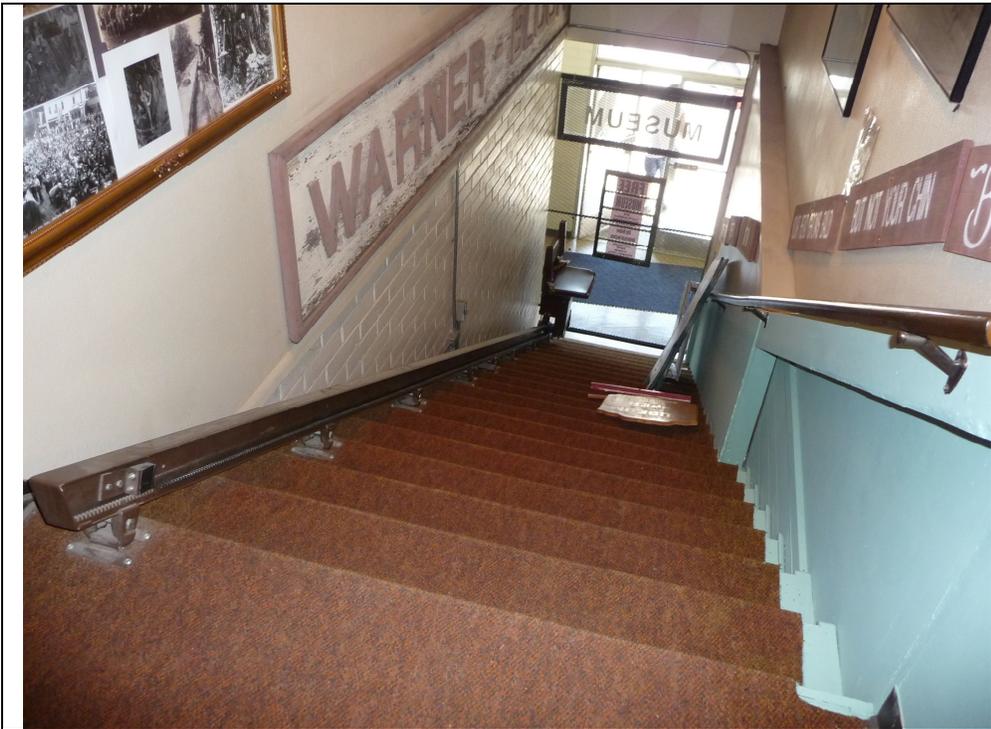
Exit stairs are not accessible. Chair lift is old fashioned. Railing has residential brackets and is missing the extensions at top and bottom.

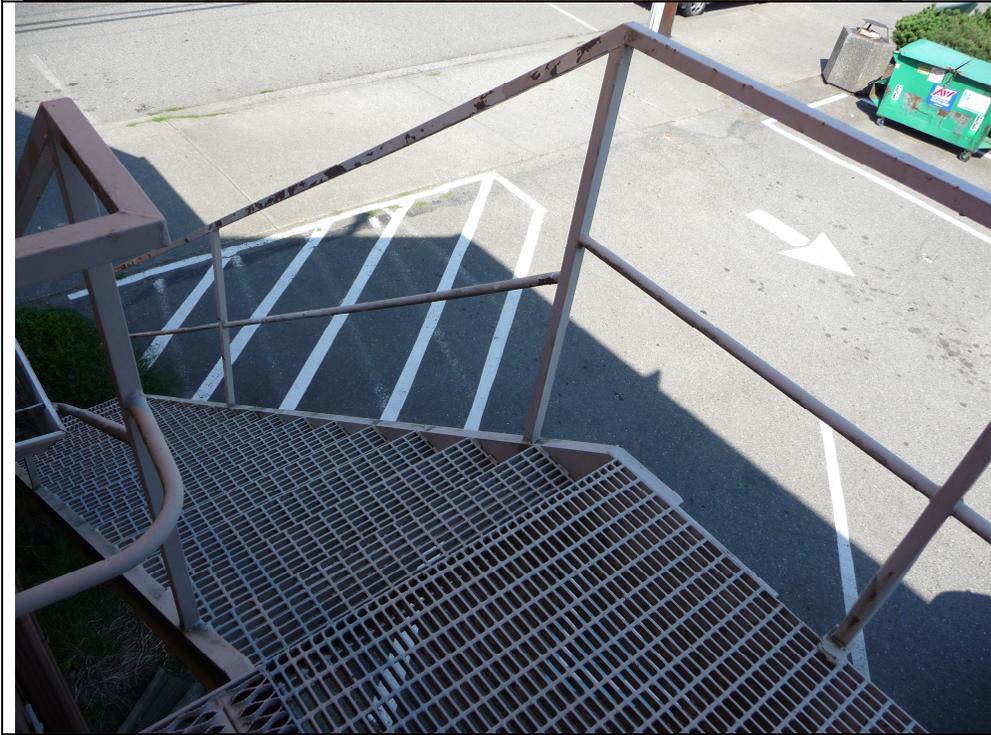
Exterior emergency exit stairs that deposit into planter. Risers are not an accessible surface; railings are gapped and not accessible. It is a dangerous route for evacuation.

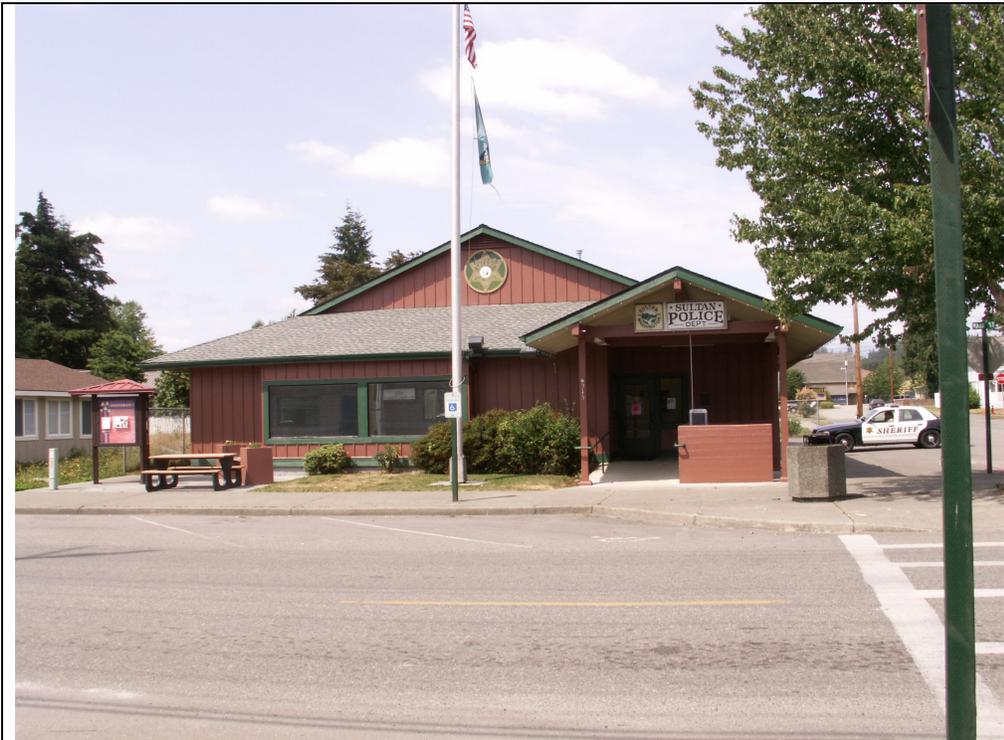
Exterior of Police Station. Good shape for the most part. Some flashings around vents may need work to keep from leaking. Sidewalk needs work on corner where tree roots are causing the sidewalk to rupture and be uneven.

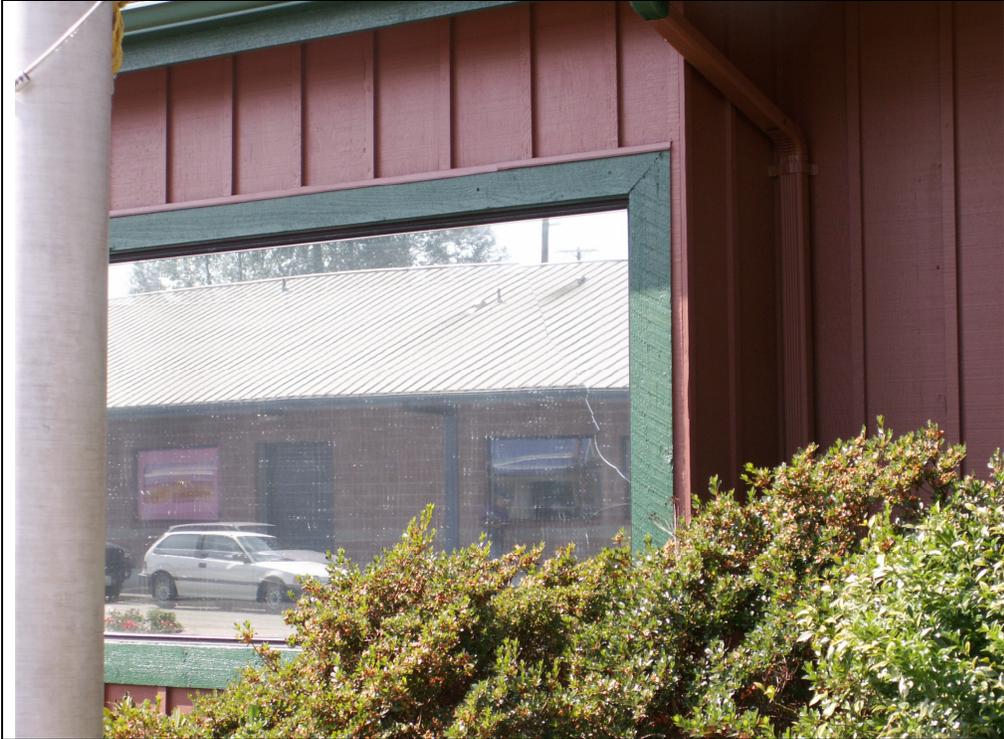
Cracking in reflective film of exterior windows needs repair. Most large windows have cracking.

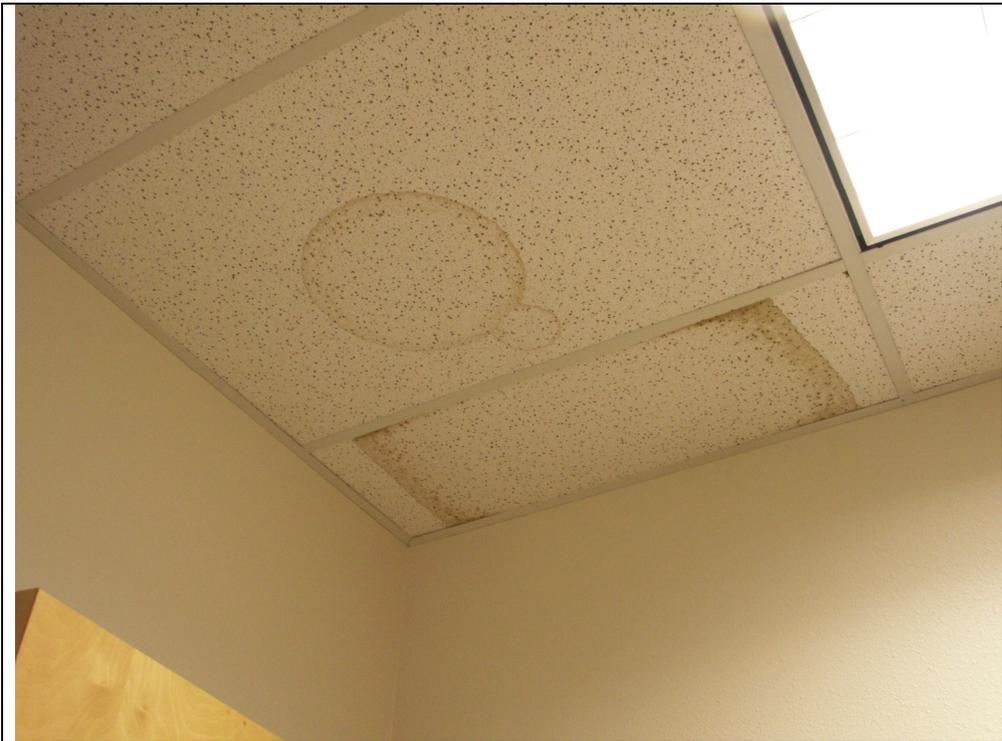
Multiple locations in ceiling showing water damage.

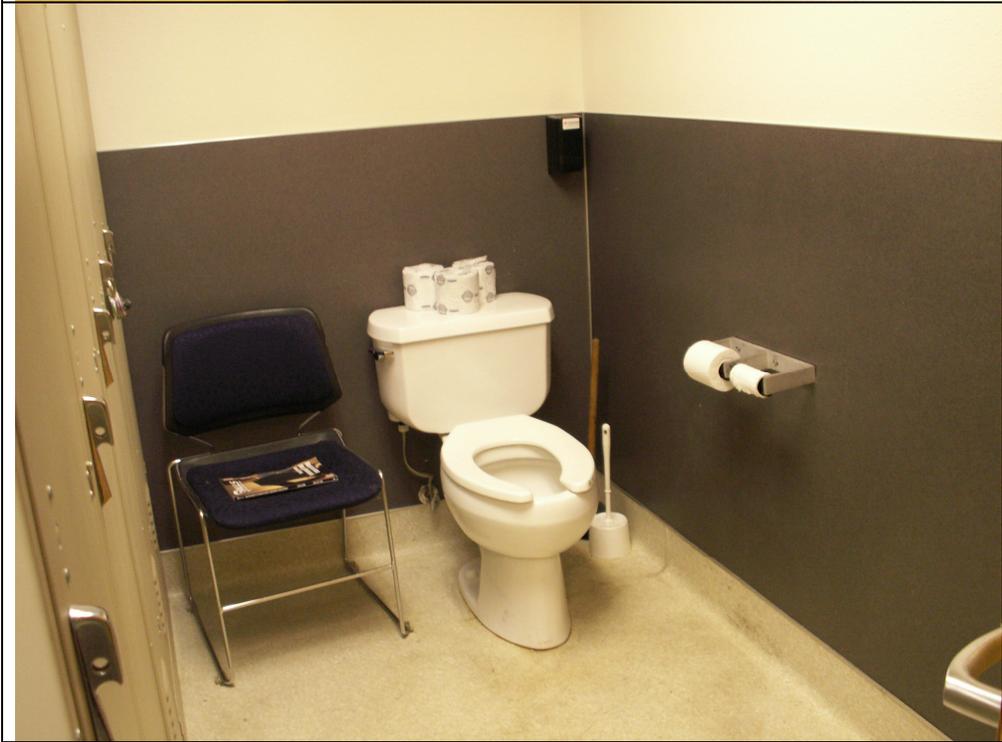
Internal restrooms are semi-accessible. Men's is missing grab bars. Shower room – shower is accessible however there is no accessible way to reach the shower due to the storage of biohazard machine in room. Public restroom is accessible.

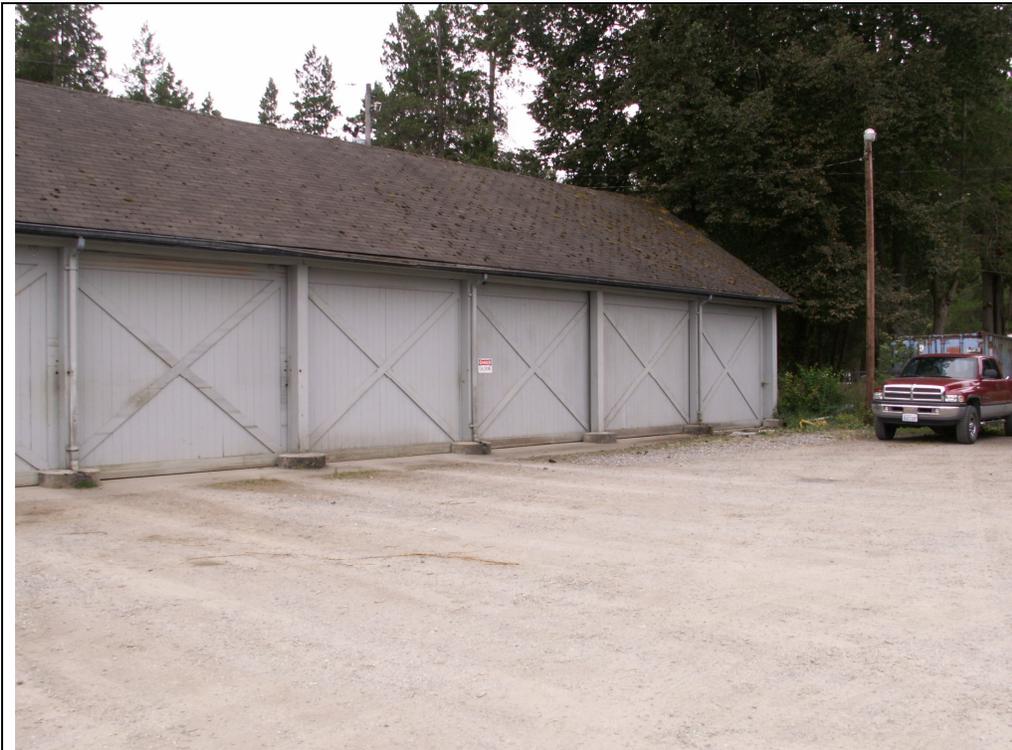
Gravel and dirt lot in poor condition with staining from spilled oil and fluids.

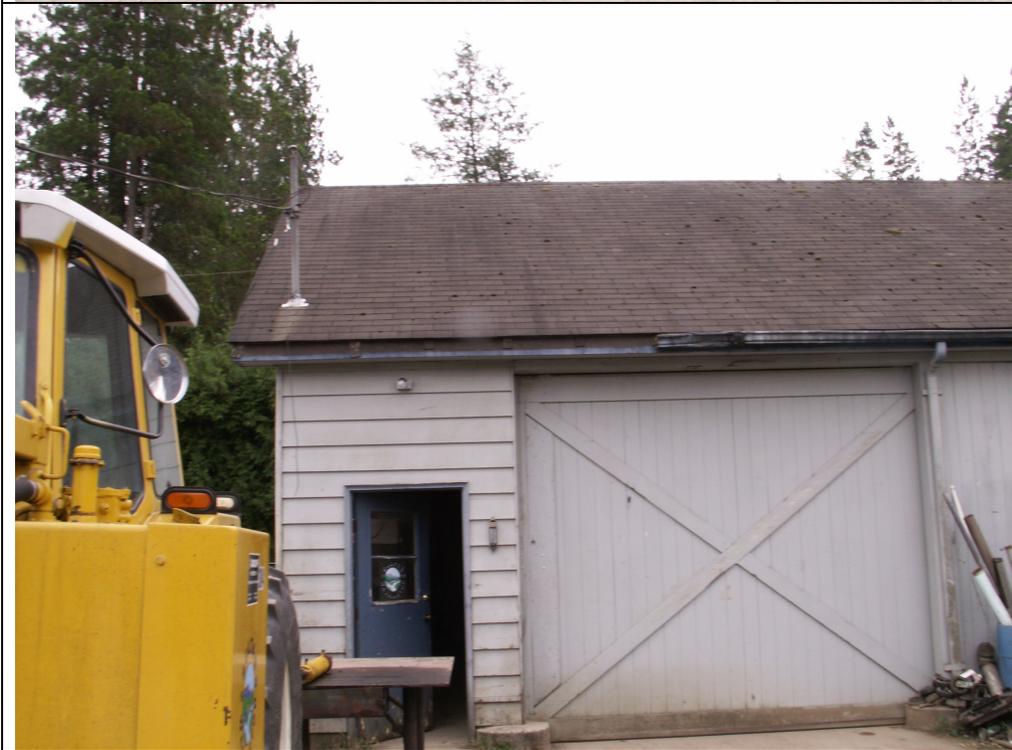
Exterior of Shop is in poor condition. Roofing needs to be replaced, gutters are missing or need repair on entire building. Building needs repainting soon. Door in very poor condition and needs replacing.

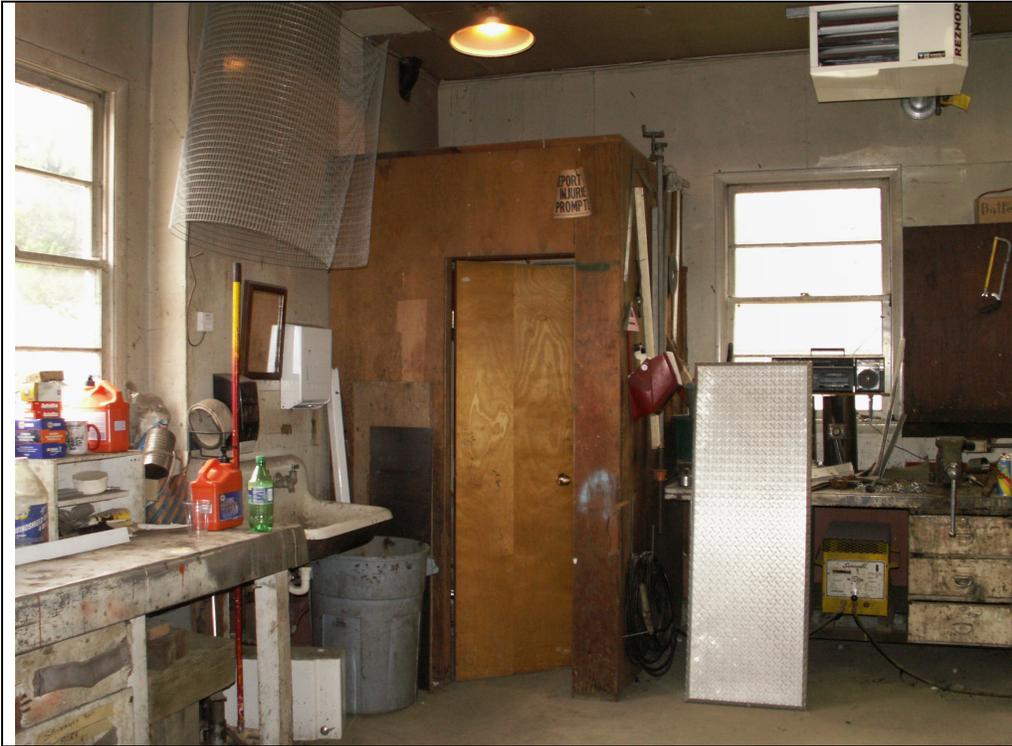
Interior of Shop is run down. Restroom is in terrible shape and looks unusable.
