Exhibit 2
City Owned Facilities Summary

CITY OWNED FACILITIES SUMMARY

Date: July 2009

**CITY OF SULTAN
Facility Assessment Study
July 24, 2009**

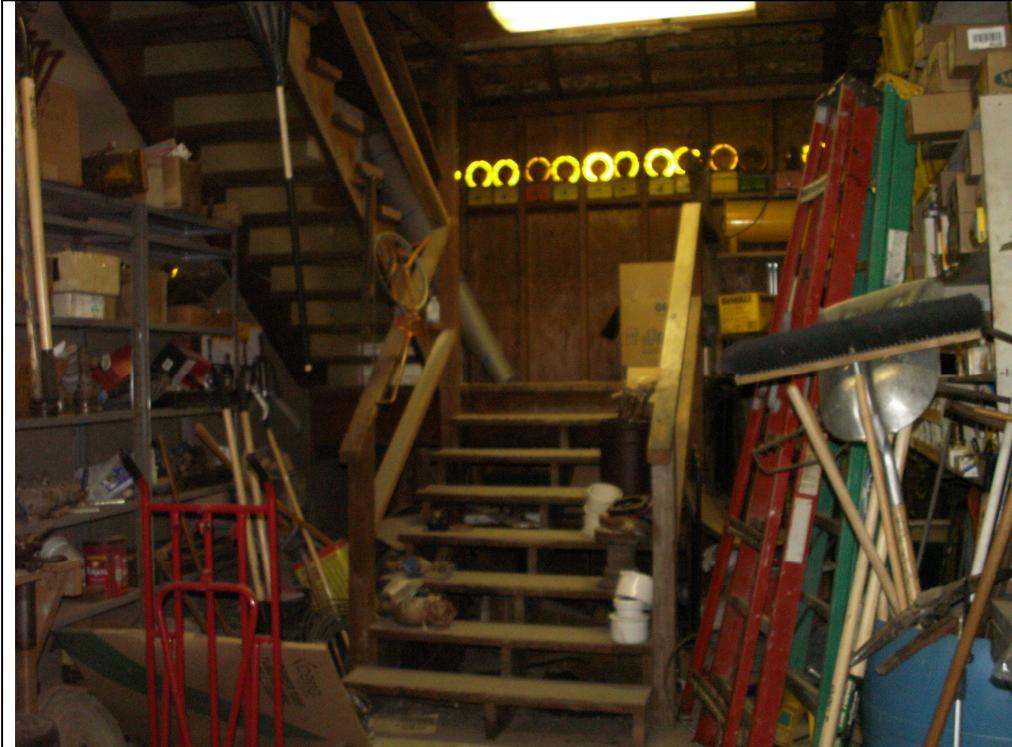
Stairs are in fair condition. Not accessible. Stairs and attic space used for storage.

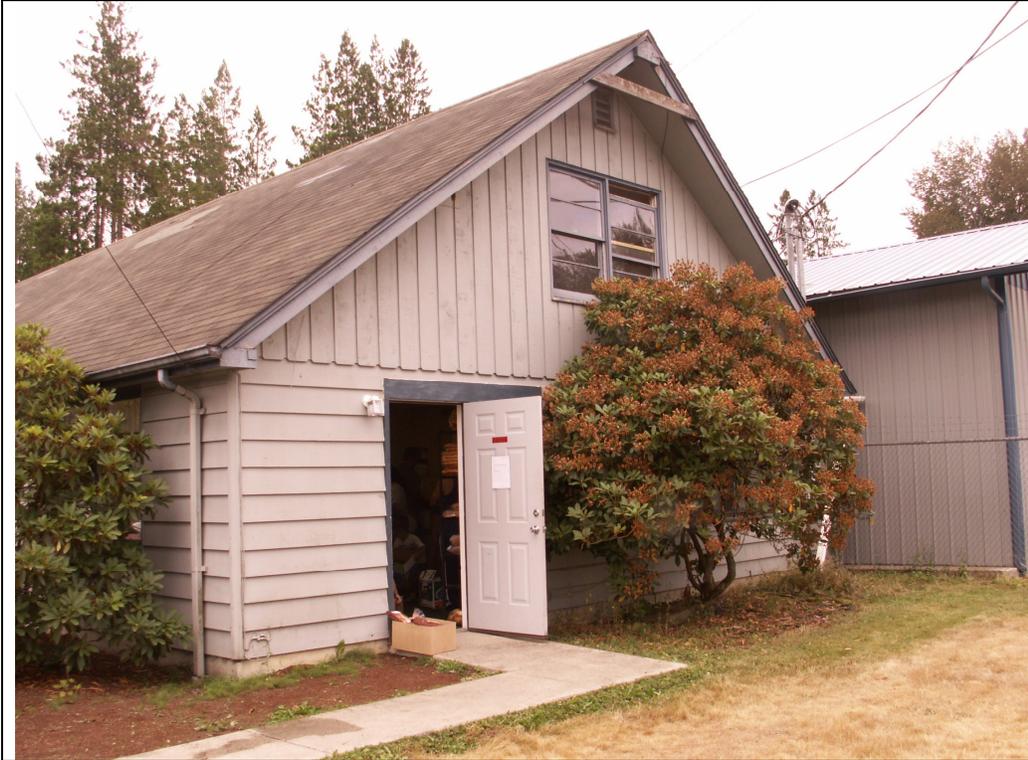
Roof of original building needs to be replaced asap. The gutters are rusted out and leak. Downspouts are disconnected from gutters in multiple locations. Wood-lap siding needs repainting.

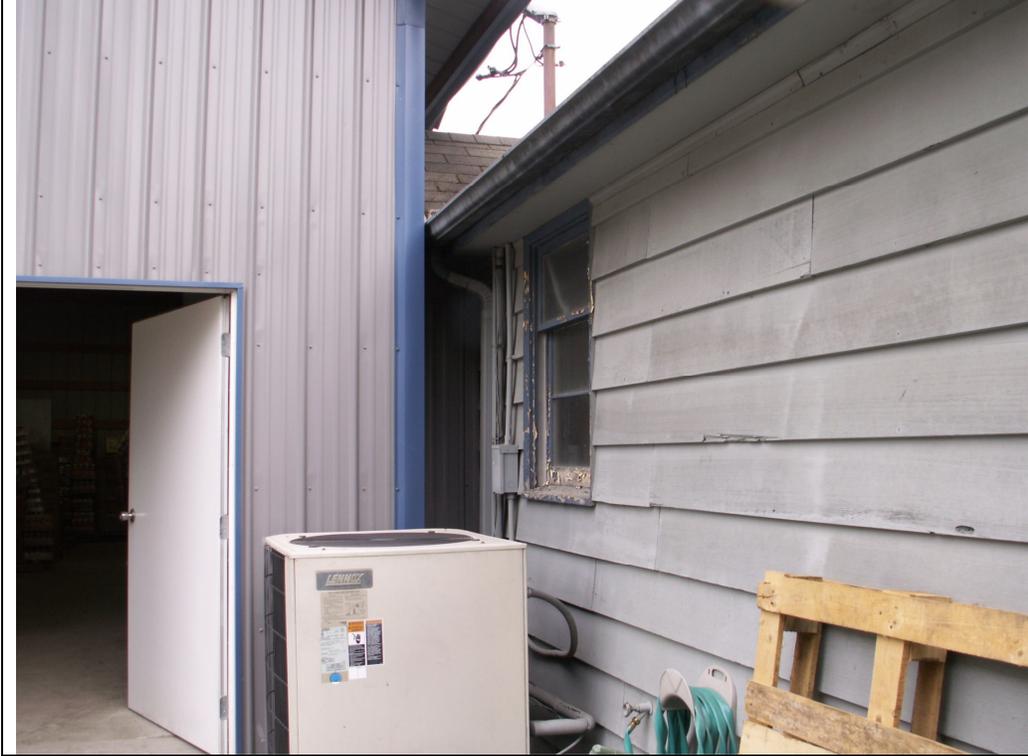
Exterior windows are in very poor shape and are very easy to open – need to be replaced or updated.

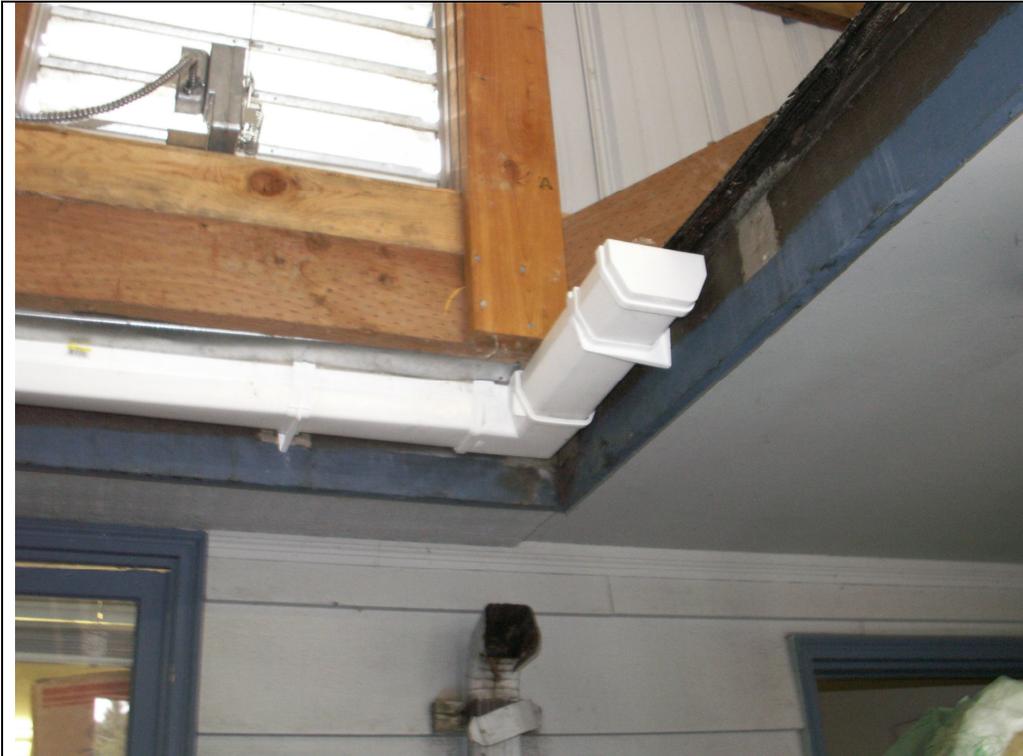
Connection between original building and new building is a major problem causing leaking into the new building.

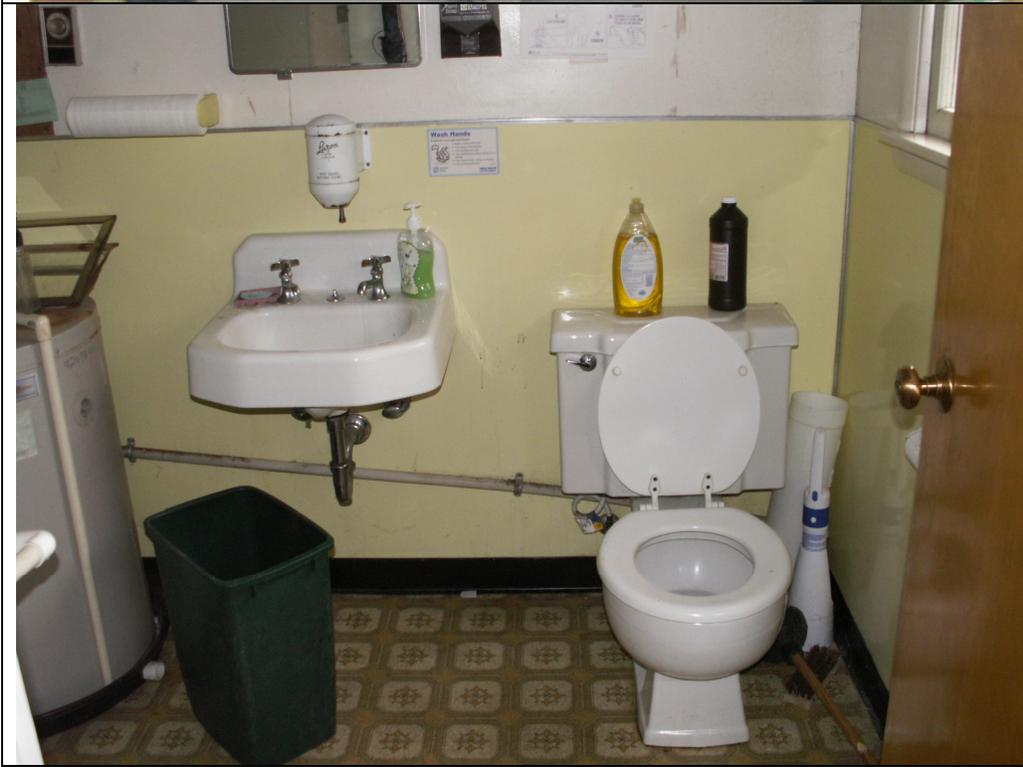
Restroom is not accessible and needs to serve 12 employees. Cold water faucet leaks. Window is too easy to open.

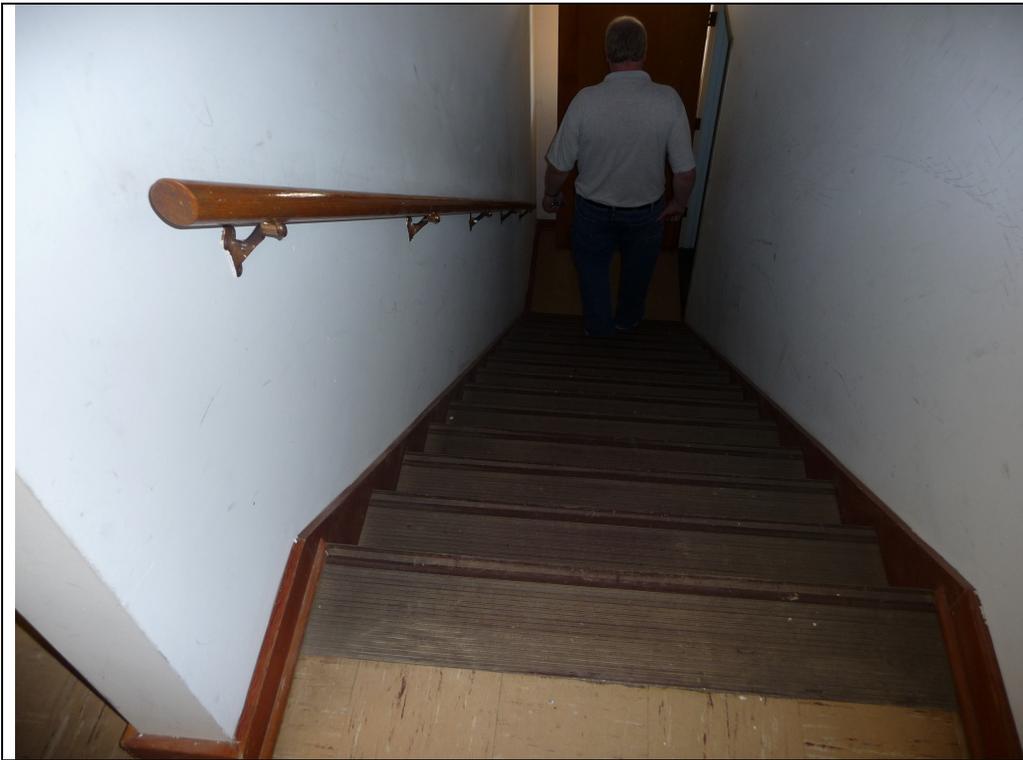
Flooring is Vinyl Tile in stairs and upper and lower floors of city side. Railing is not compliant (missing extensions on top and bottom) and has residential brackets.

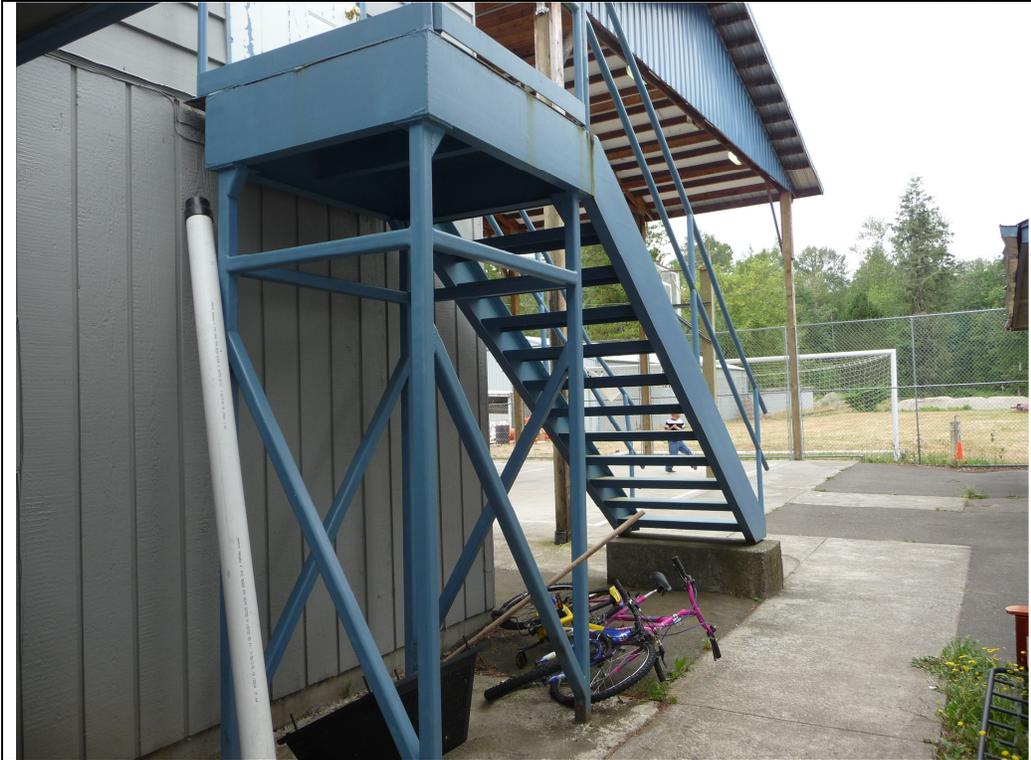
Exterior Stairs on both sides of building not to code and unsafe. Rise is different between metal and concrete steps. Not conducive to emergency situations, especially in a building serving children.

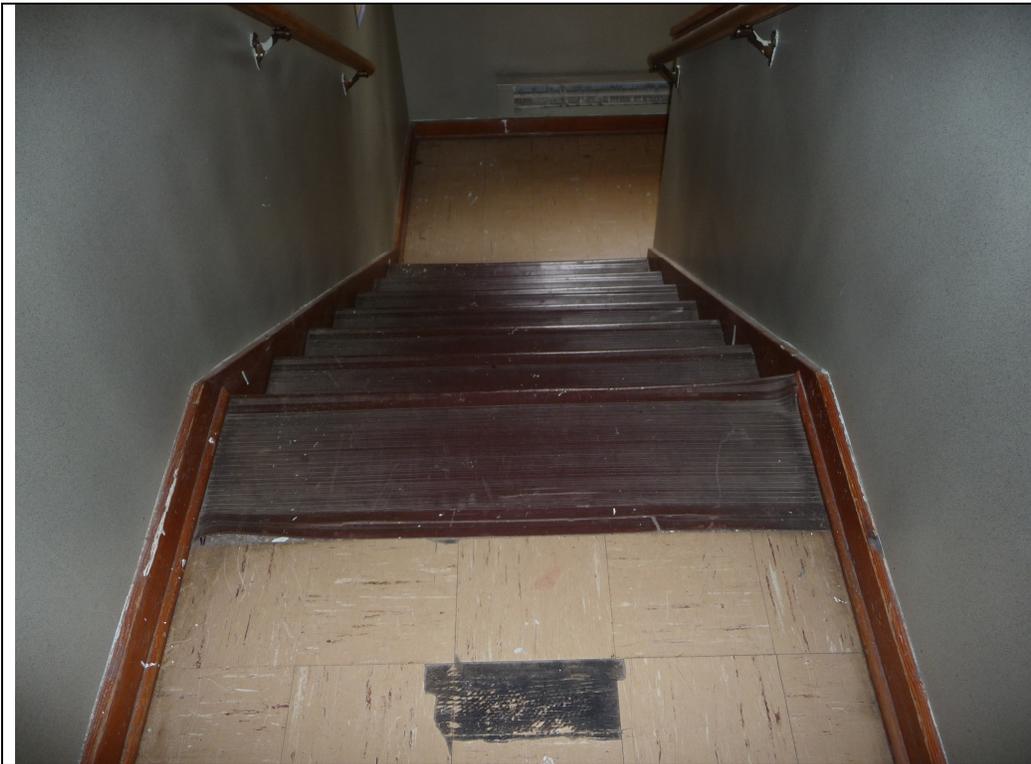
Interior Stairs
– 9x9 Vinyl
Tiles with
rubber treads.
Stairs in poor
condition.
Railings are on
residential
brackets and
missing
extensions on
top and
bottom. Not
accessible.
Flooring in
most of the
building is
vinyl tile.

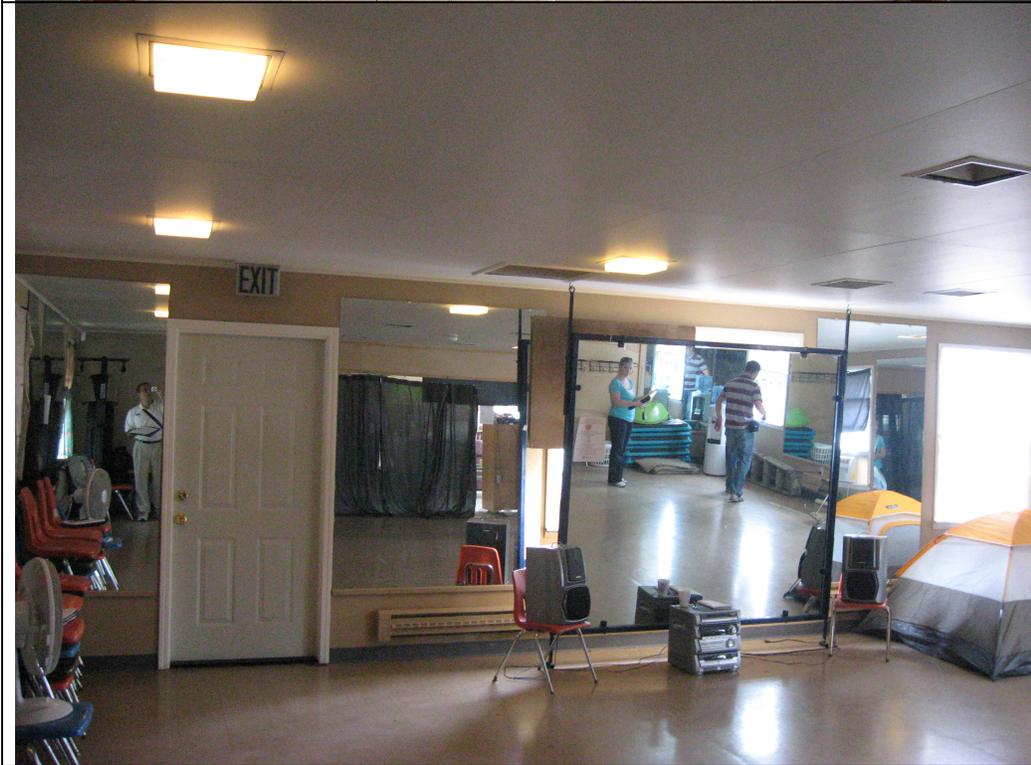
Emergency
exit doors
from second
floor do not
have panic
hardware, have
knob handles,
and is very
difficult to
open.
Dangerous for
emergency
situations.

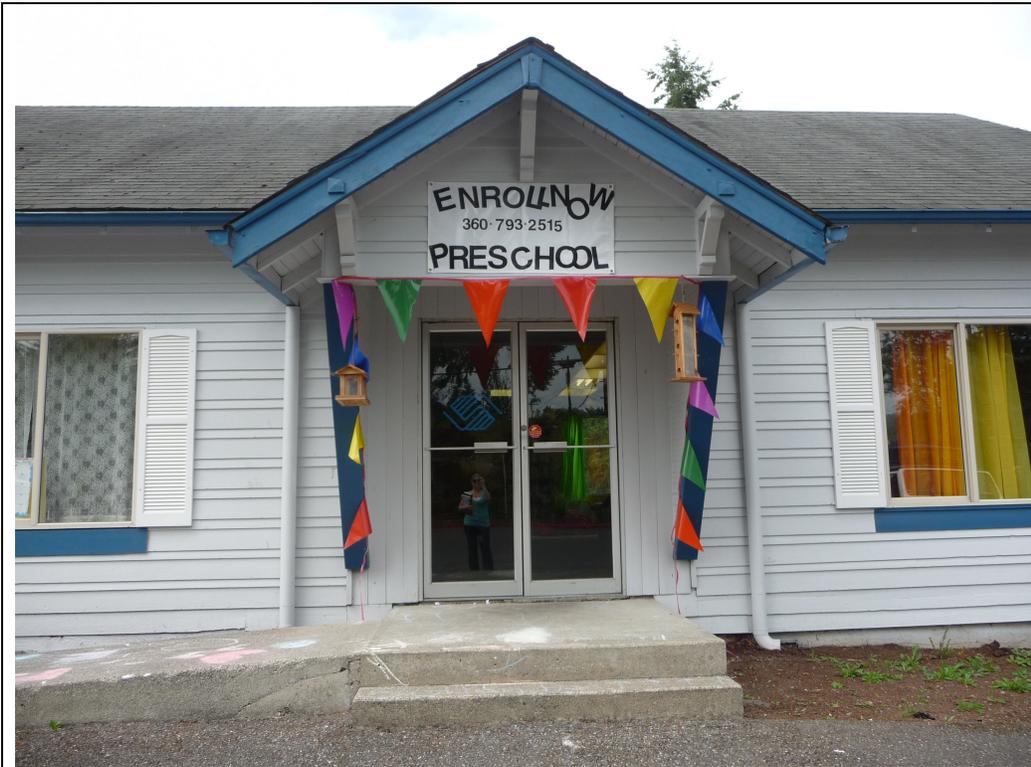
Exterior of Boys and Girls Club 1 Story Building - Ramp is broken and has no handrails. Needs to be replaced. Doors are in poor condition and need to be replaced. Replacement and maintenance of siding is needed.

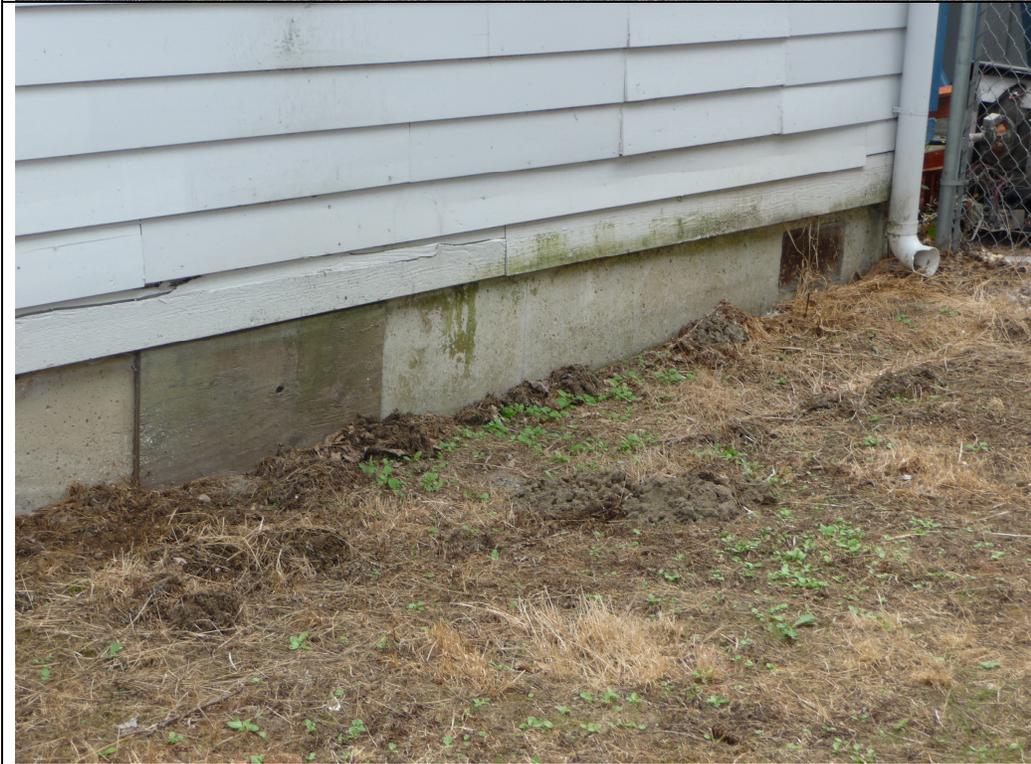
Due to crawlspace vents, we assume there is a crawlspace. Most likely non-code compliant. Gutter daylighted into depressed area by crawlspace vent and we assume this can cause decay, mold and deterioration of floor structure.

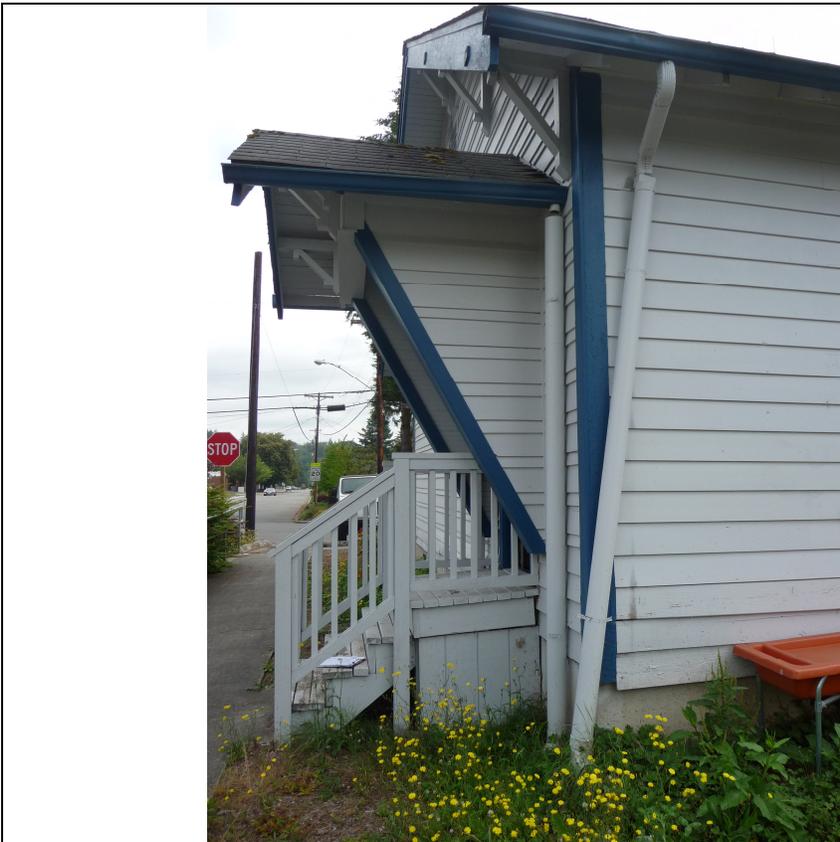
Second exit – door swings inward rather than out, has knob hardware and is thus a non-compliant exit door. Wood steps vary in height from 8 ¼” to 7” and the decking is in poor shape rotting and one deck board is broken.

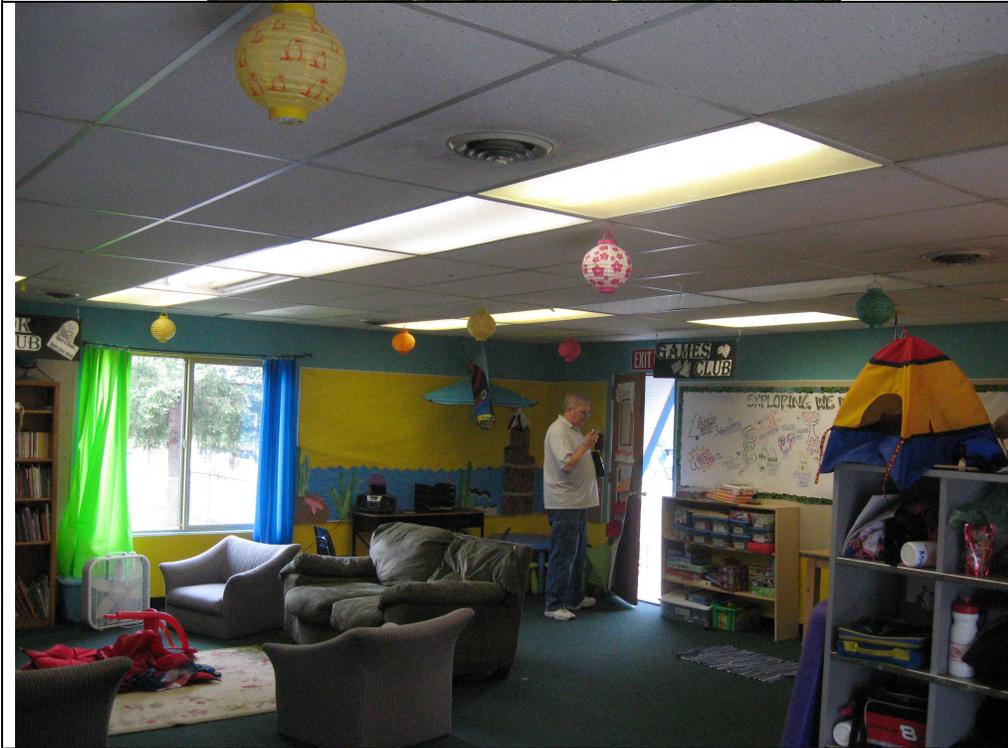
Flooring is a green carpet that is delaminating in some areas and in poor shape so needs replacement soon. The cover rubber base has problems as well.

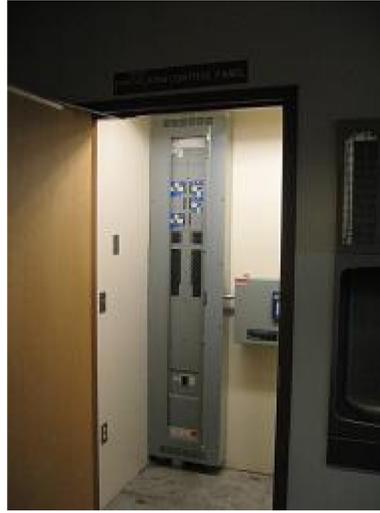
Electrical Room – code clearance
but little room for expansion

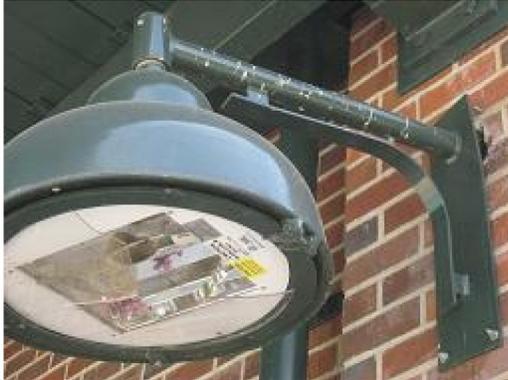
The building exterior lighting has been damaged by vandalism, the damage primarily in the form of cracked or shattered lenses. The luminaire at the Northeast corner of the building also has damage to the mounting anchors, and the luminaire at the Southeast corner of the building has been retrofitted with a compact fluorescent lamp, incompatible with the HID ballast in the luminaire.

Exterior luminaire at the Northeast corner of the Building. Note shattered lens, and damaged mounting bracket and anchors.

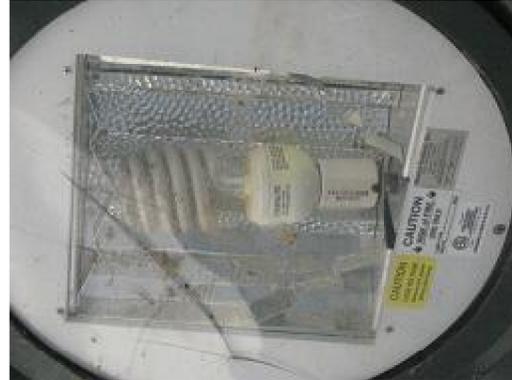
Exterior luminaire at the Southeast corner of the building. A compact fluorescent lamp has been installed in the socket of a metal-halide lamped fixture.

- The building exterior luminaire at the Southeast corner of the building has been retro-fitted with a compact fluorescent lamp. This is designed as a Metal halide lamped luminaire, and this fixtures should be repaired as soon as practical.

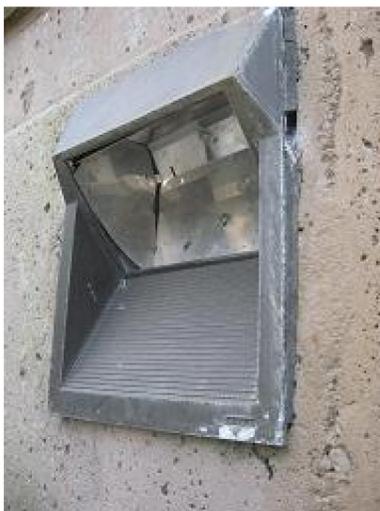
Damaged parking area luminaire.
The lens, lamp socket, and reflector
have been vandalized.

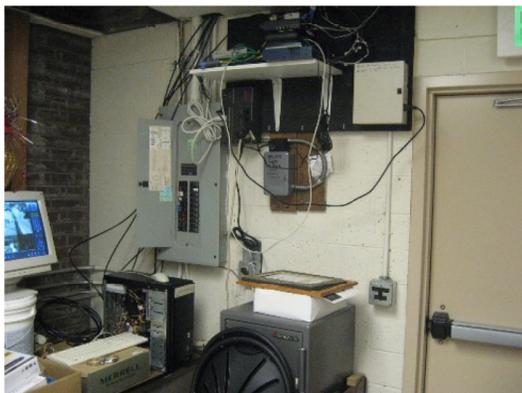
Building Electrical Panel and Telecom equipment. Note area clutter and obstructions to access.

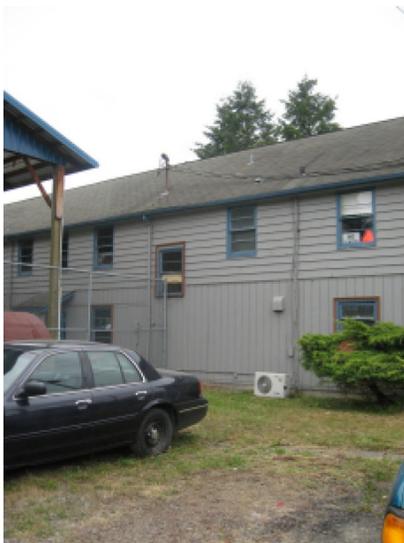
- The aerial service drop cables are in contact with the sloped roof, and need to be re-supported to comply with State code clearance requirements. Since these conductors are on the load-side of the service/metering pole, these conductors are owned by the city, and thus are not maintained by the Snohomish County PUD. We understand that the PUD has provided a cost budget to remedy the sagging conductors. We recommend that the City solicit competitive bids from electrical contractors to provide conductor support in accordance with WAC 296-46B requirements.
- The branch circuit panel serving the kitchenette is located above a counter, and does not meet code required working space clearance.

Aerial power conductors sagging,
in contact with sloped roof.
