Exhibit 2
City Owned Facilities Summary

CITY OWNED FACILITIES SUMMARY

Date: July 2009

**CITY OF SULTAN
Facility Assessment Study
July 24, 2009**

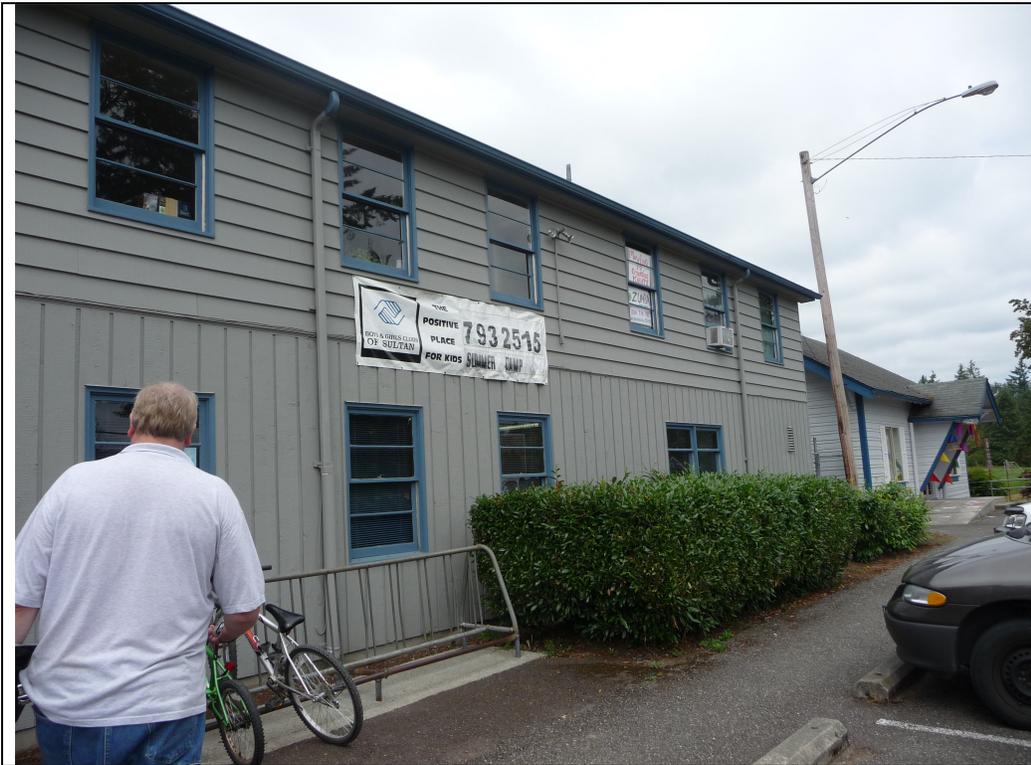
Boys and Girls 2 Story Building

Exterior of Boys and Girls 2 Story Building.

Exterior Stairs on both sides of building not to code and unsafe. Rise is different between metal and concrete steps. Not conducive to emergency situations, especially in a building serving children.

Interior Stairs
– 9x9 Vinyl
Tiles with
rubber treads.
Stairs in poor
condition.
Railings are on
residential
brackets and
missing
extensions on
top and
bottom. Not
accessible.
Flooring in
most of the
building is
vinyl tile.

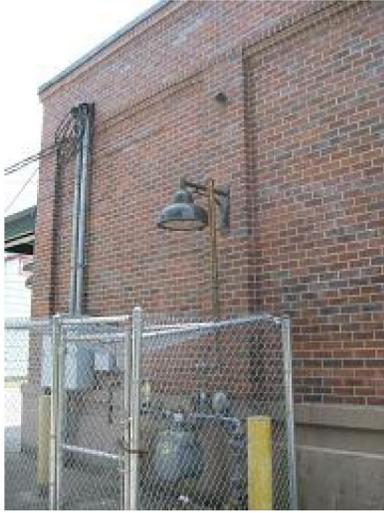
Service Drop, Metering
Note height of ext. luminaires

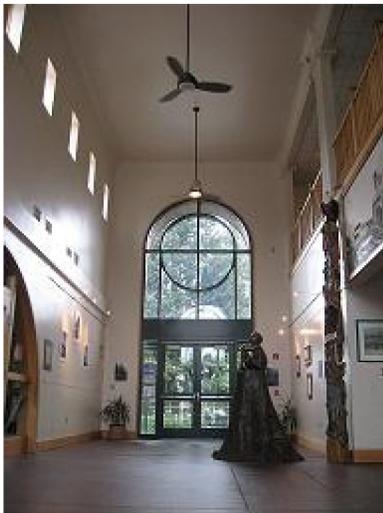
Lighting in the main entry lobby was originally designed as decorative direct/indirect HID luminaires, and has, in the last 2 years, been replaced with commercial/retail type paddle fans with integral incandescent direct lighting.

Lobby – paddle fans with integral lights. LV art/bulletin lights.

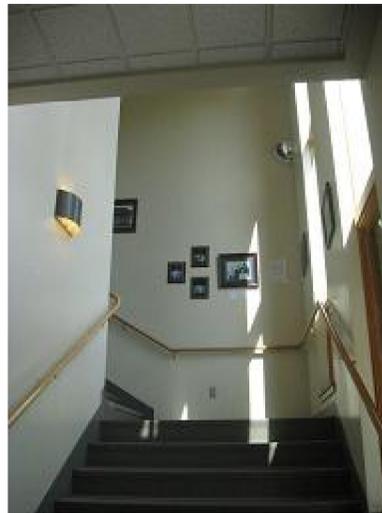
Lighting in the lobby stair is comprised of downlights and wall sconces. This is a well-lit daylight zone, and auto switching of the lighting in this area will conserve significant energy savings over time.

Daylit lobby stair with sconce lights on.
